Technical Memorandum

To: Musselshell Watershed Coalition
From: Jon Jupka, P.E., CFM
CC: Karin Boyd and George Austiguy, P.E.
Date: 6/3/2022
Re: Rowton and Cushman Bridge Preliminary Engineering Report

Rowton Property Bank Restoration

Cushman Bridge

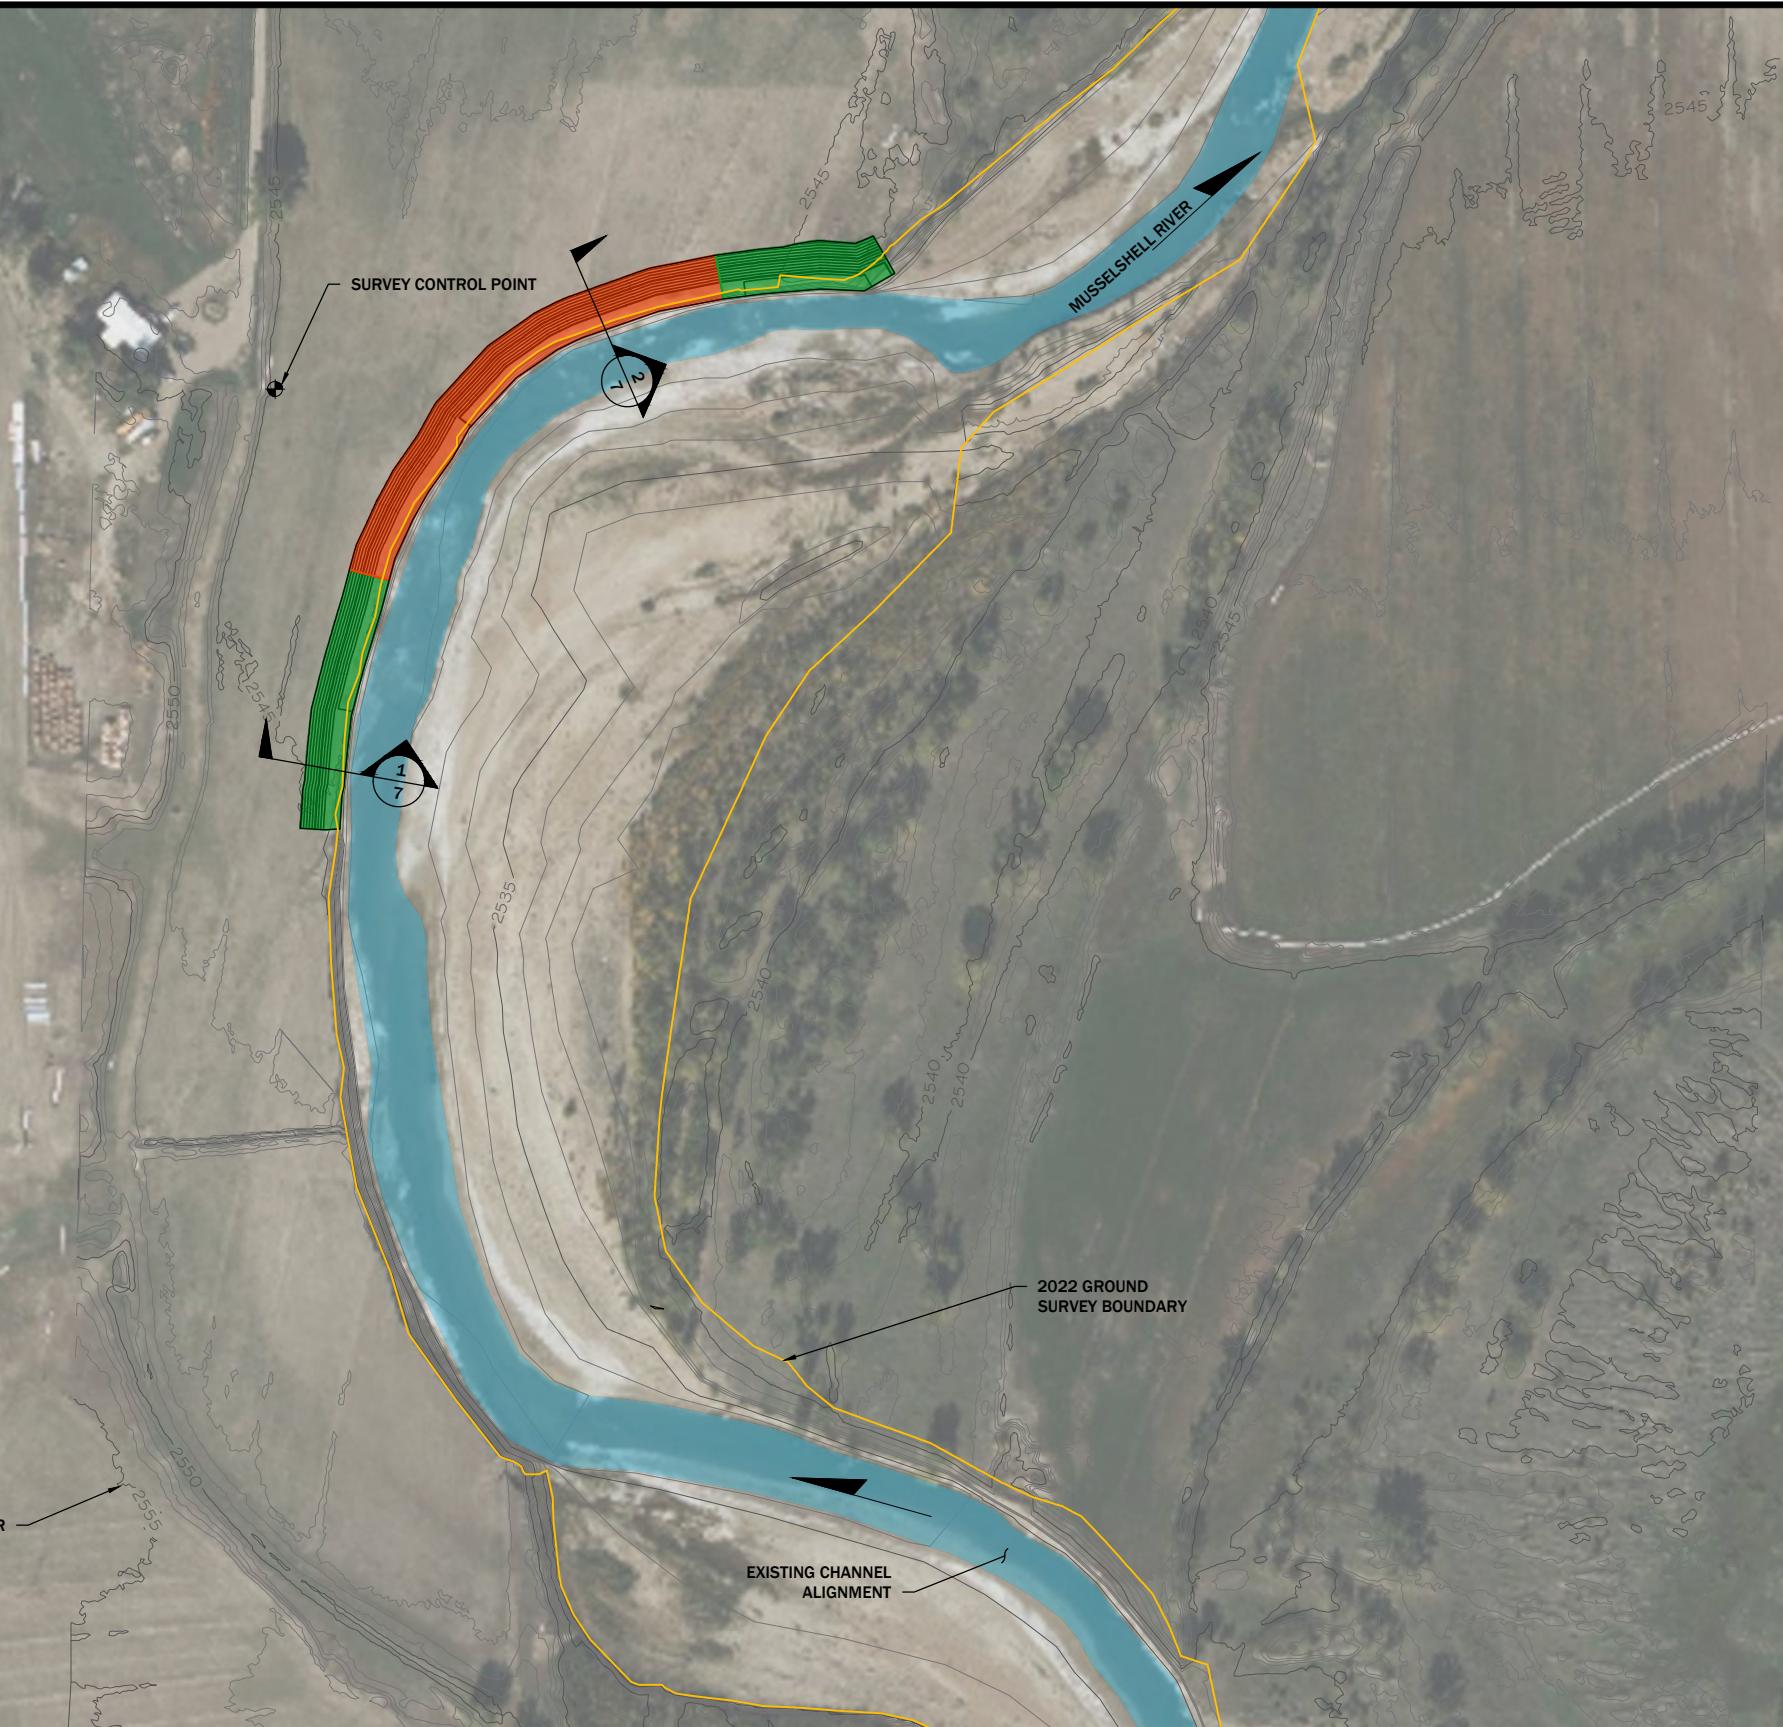
FIGURE 2
PIONEER
 TECHNICAL SERVICES, INC.
www.pioneer-technical.com
 (406) 782-5177

- TYPE 1 BANK TREATMENT
- TYPE 2 BANK TREATMENT

ROWTON PROPERTY
 BANK RESTORATION
 ALTERNATIVE 1
 PLAN VIEW

Two alternatives were proposed for the Rowton Property Bank restoration project, as shown in Figure 2 and Figure 3. The first alternative would provide bank treatment for the more actively eroding reach of bank. This alternative would start at the meander bend's downstream end and continue ~1,000ft upstream. The second alternative would provide bank treatment for entire ~1,800 ft of eroding meander bend. Two brush matrix bank treatment variations are proposed. For areas that are expected to see higher erosive forces an erodible rock toe will be placed in the channel beneath the brush matrix. This rock toe is intended to withstand more frequent flood events but can be mobilized at less frequent flood events. This will provide a better chance for the new vegetation to establish, while still allowing the river the ability to adjust during large flood events. Figure 7 shows the typical brush matrix bank treatments. Additional detailed survey and engineering analysis will be required for final construction level design.

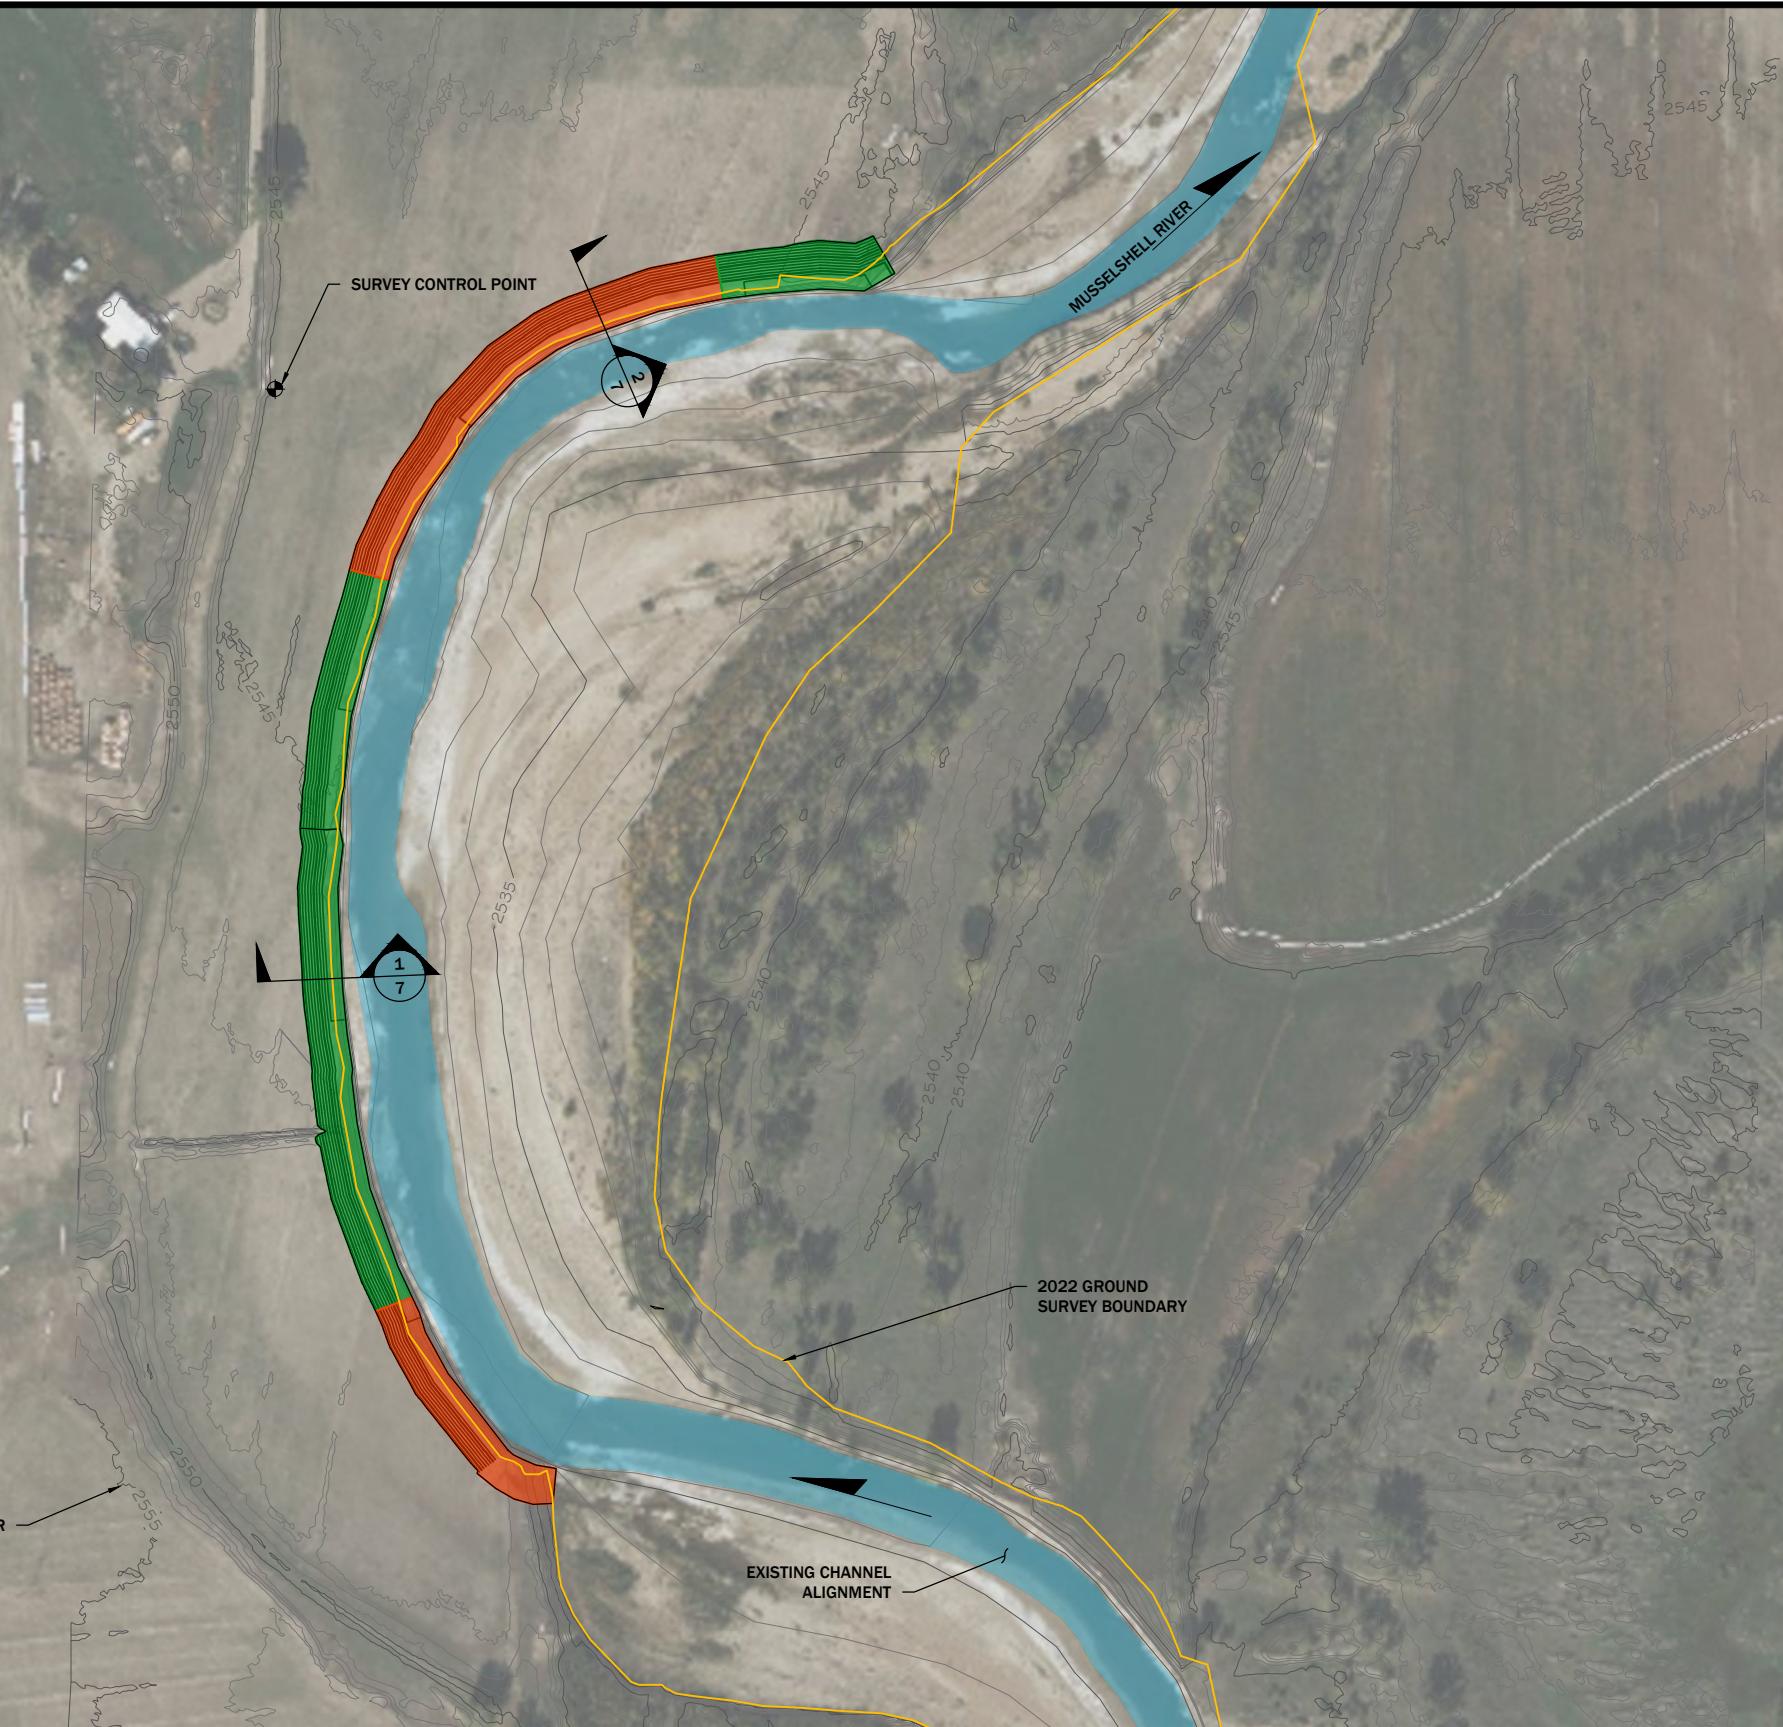
FIGURE 3
PIONEER
 TECHNICAL SERVICES, INC.
www.pioneer-technical.com
 (406) 782-5177

- TYPE 1 BANK TREATMENT
- TYPE 2 BANK TREATMENT

ROWTON PROPERTY
 BANK RESTORATION
 ALTERNATIVE 2
 PLAN VIEW

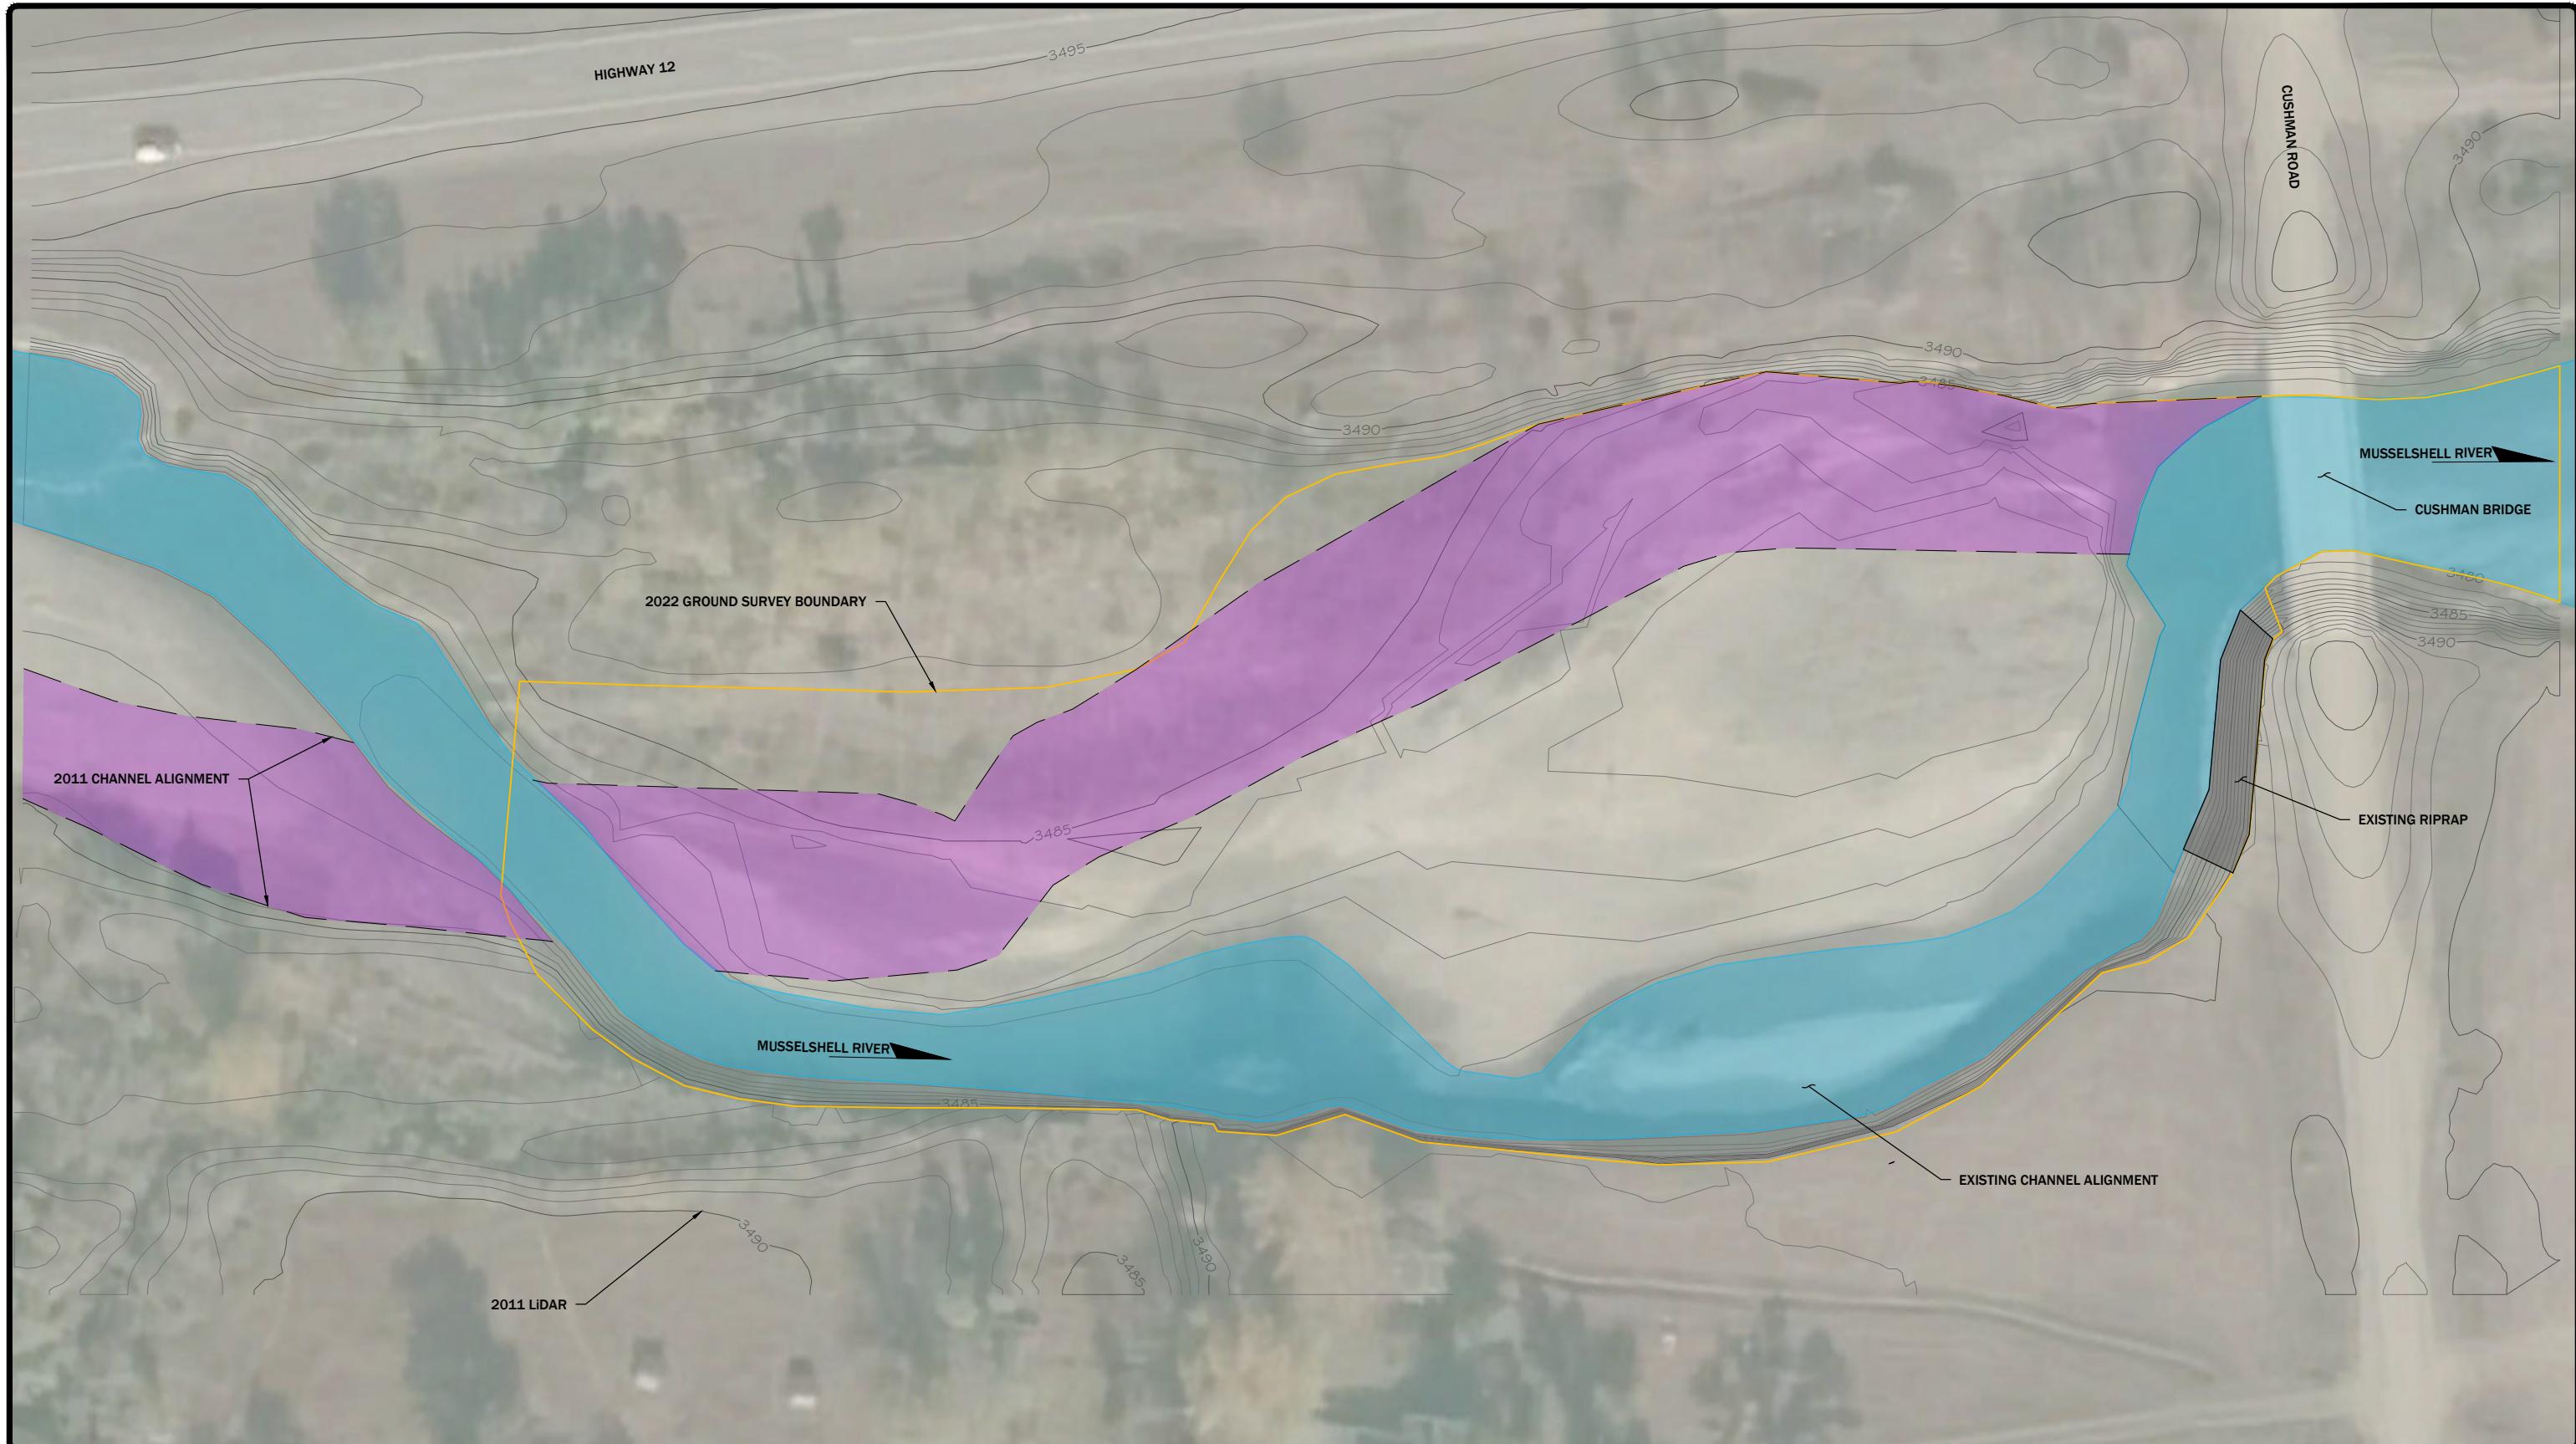
CUSHMAN BRIDGE SITE MAP EXISTING CONDITIONS

When the Cushman Bridge was installed, the Musselshell River upstream of the crossing was relatively straight and streamflow traveled perpendicular to Cushman Road. Since the 2011 flood event, the south bank has started eroding as the river attempts to lengthen. The river has abandoned the old channel and now flows in a new channel to the south and has created a meander bend just west of Cushman Road (Figure 4). The erosion has resulted in loss of land and if continues, may endanger Cushman Road. The project objective is to reduce the erosion potential, improve aquatic and riparian habitat, and improve the hydraulic bridge approach. The Cushman Bridge site objective will be to have a less deformable toe than Rowton, the degree of protection will be determined by stake holders during final design. The Cushman Bridge is in a mapped Zone AE (no Floodway) reach of the Musselshell River.

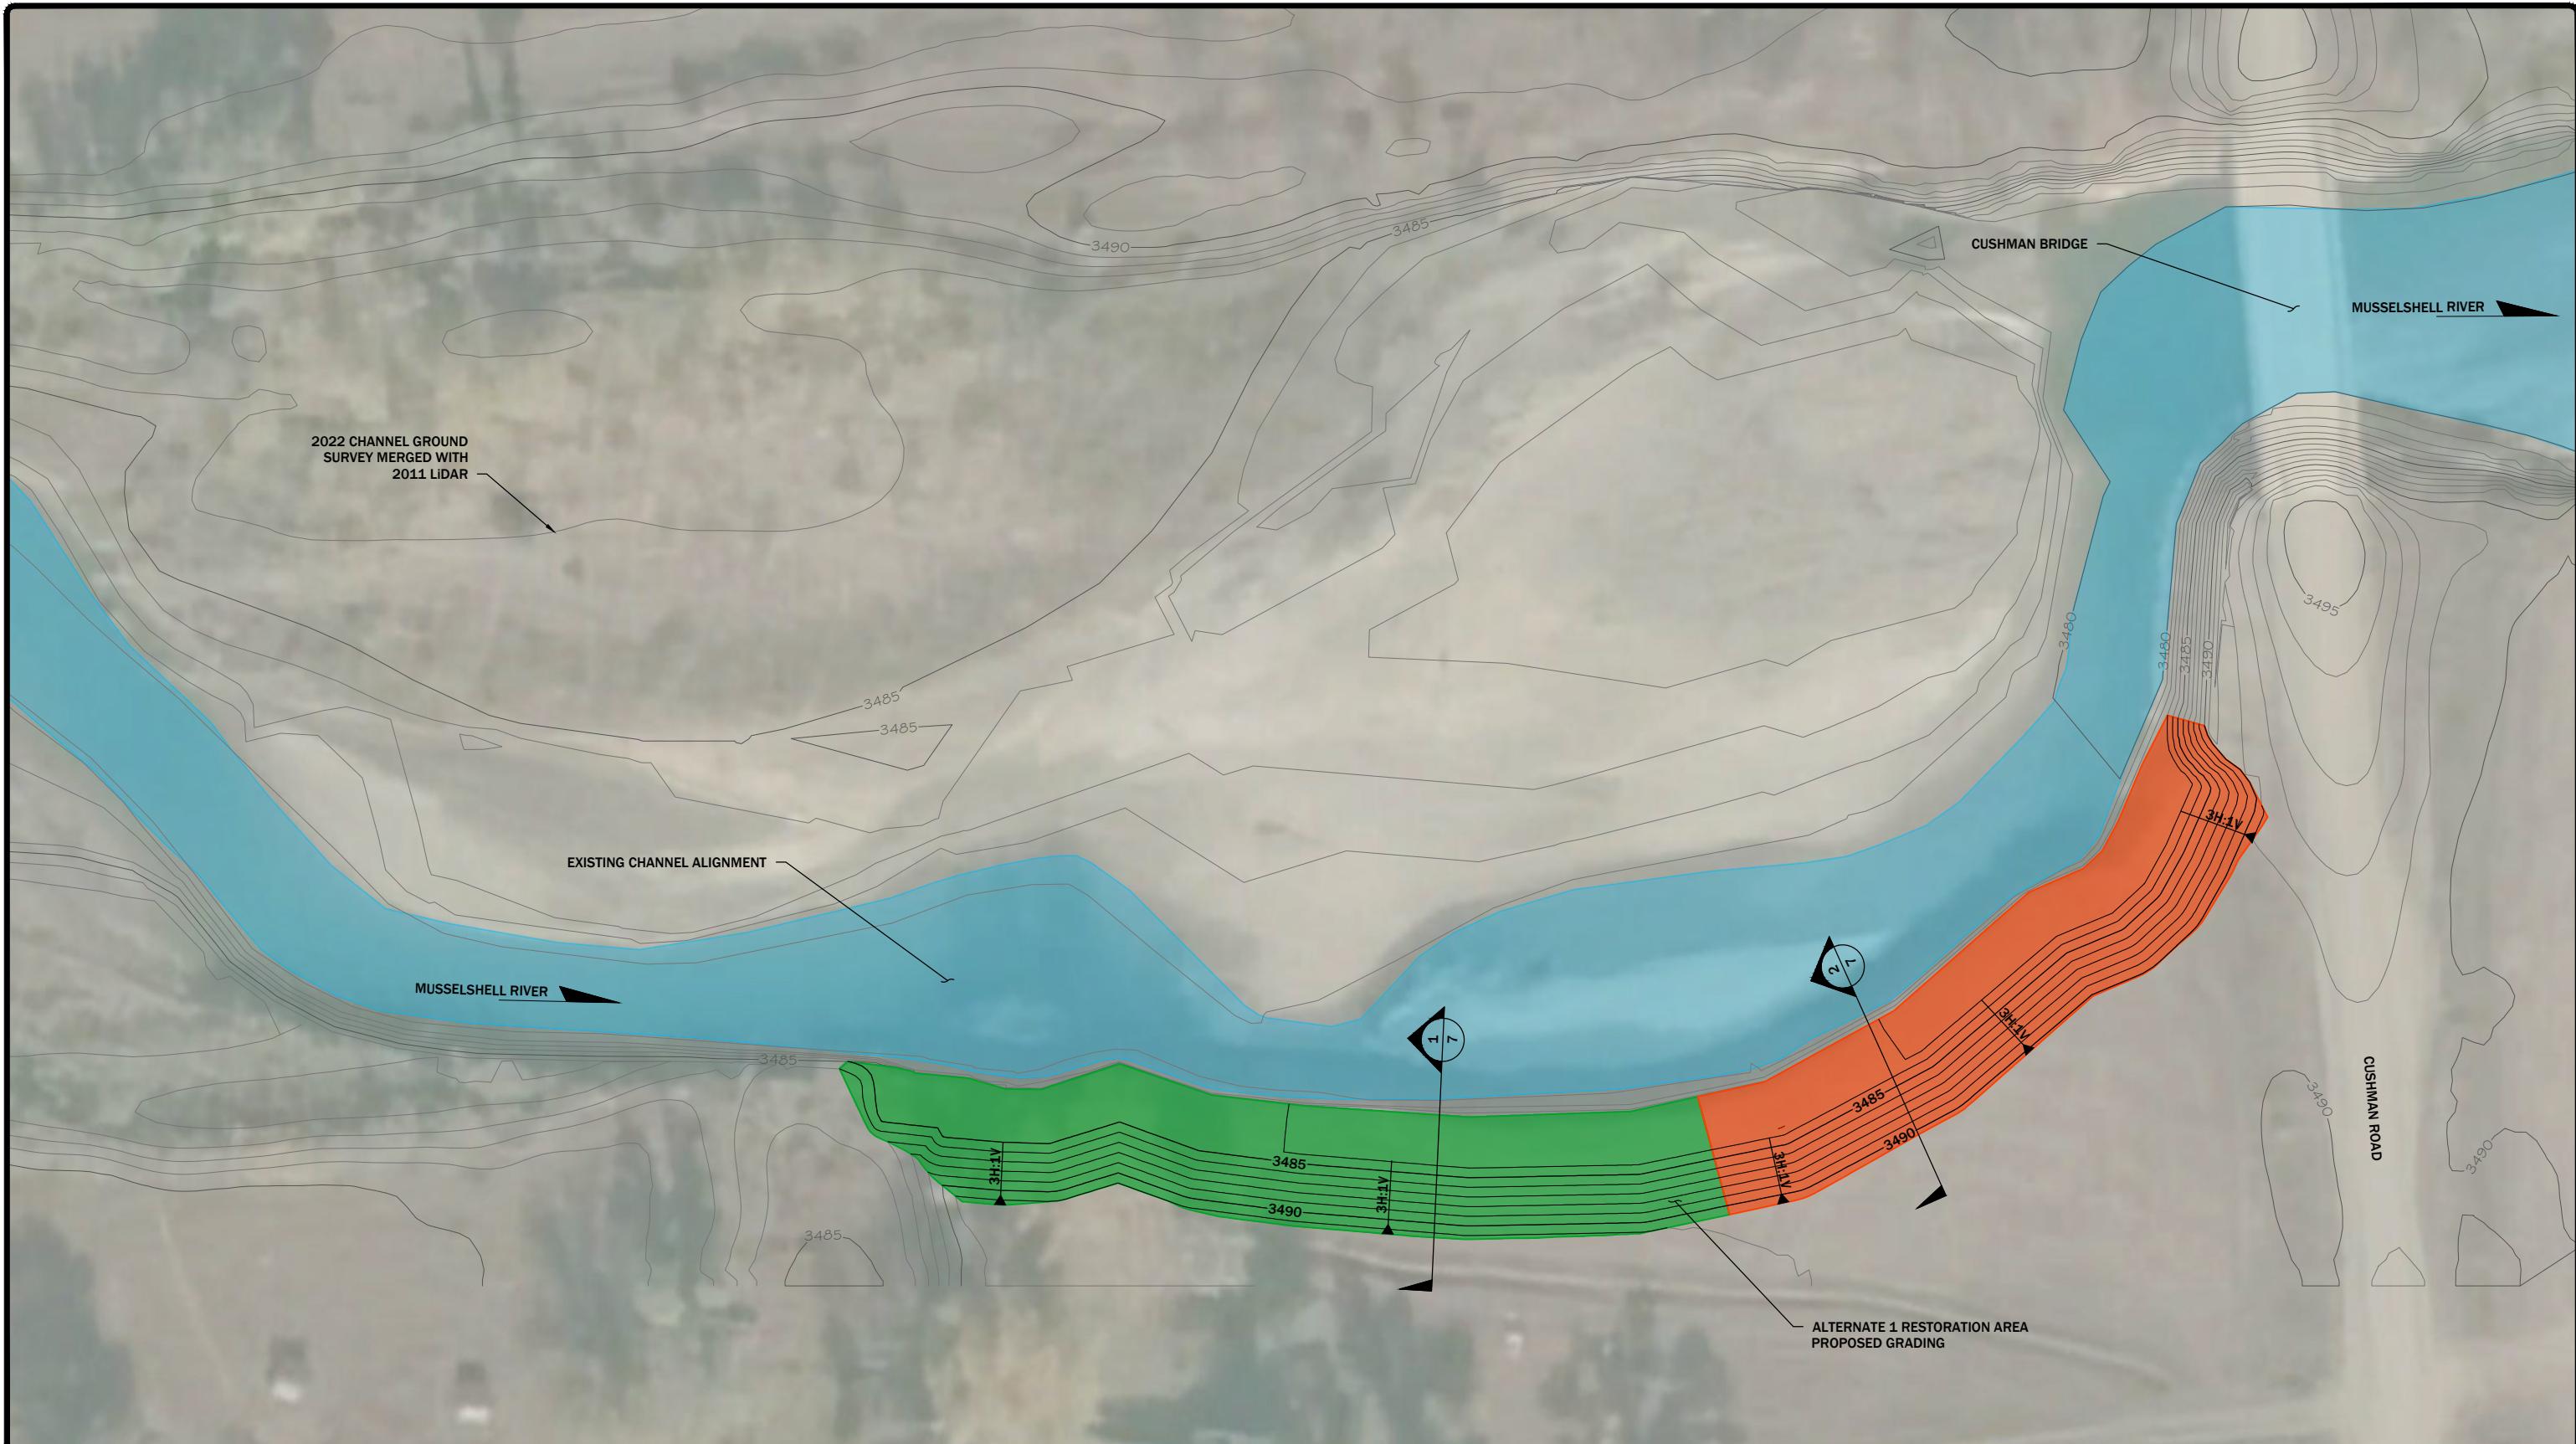
FIGURE 5
PIONEER
 TECHNICAL SERVICES, INC.
www.pioneer-technical.com
 (406) 782-5177

- TYPE 1 BANK TREATMENT
- TYPE 2 BANK TREATMENT

CUSHMAN BRIDGE
 BANK RESTORATION
 ALTERNATIVE 1
 PLAN VIEW

The first alternative consists of a similar brush matrix bank treatment as proposed for on the Rowton Property (Figure 6), new bank will be constructed with coarse alluvium, willow cuttings and woody debris. The treatment will also include a small bench (10'-15') with willow cuttings and grading the steep cut bank back to a milder slope (3 horizontal to 1 vertical [3:1]). The brush matrix bank treatment will be placed near bankfull flow elevation and planted with locally harvested willow cuttings (Figure 5).

The first alternative would provide bank treatment for approximately 475 feet. Figure 7 shows the typical brush matrix bank treatment. This alternative would not move the river from its current alignment. Additional detailed survey and engineering analysis will be required for final construction level design.

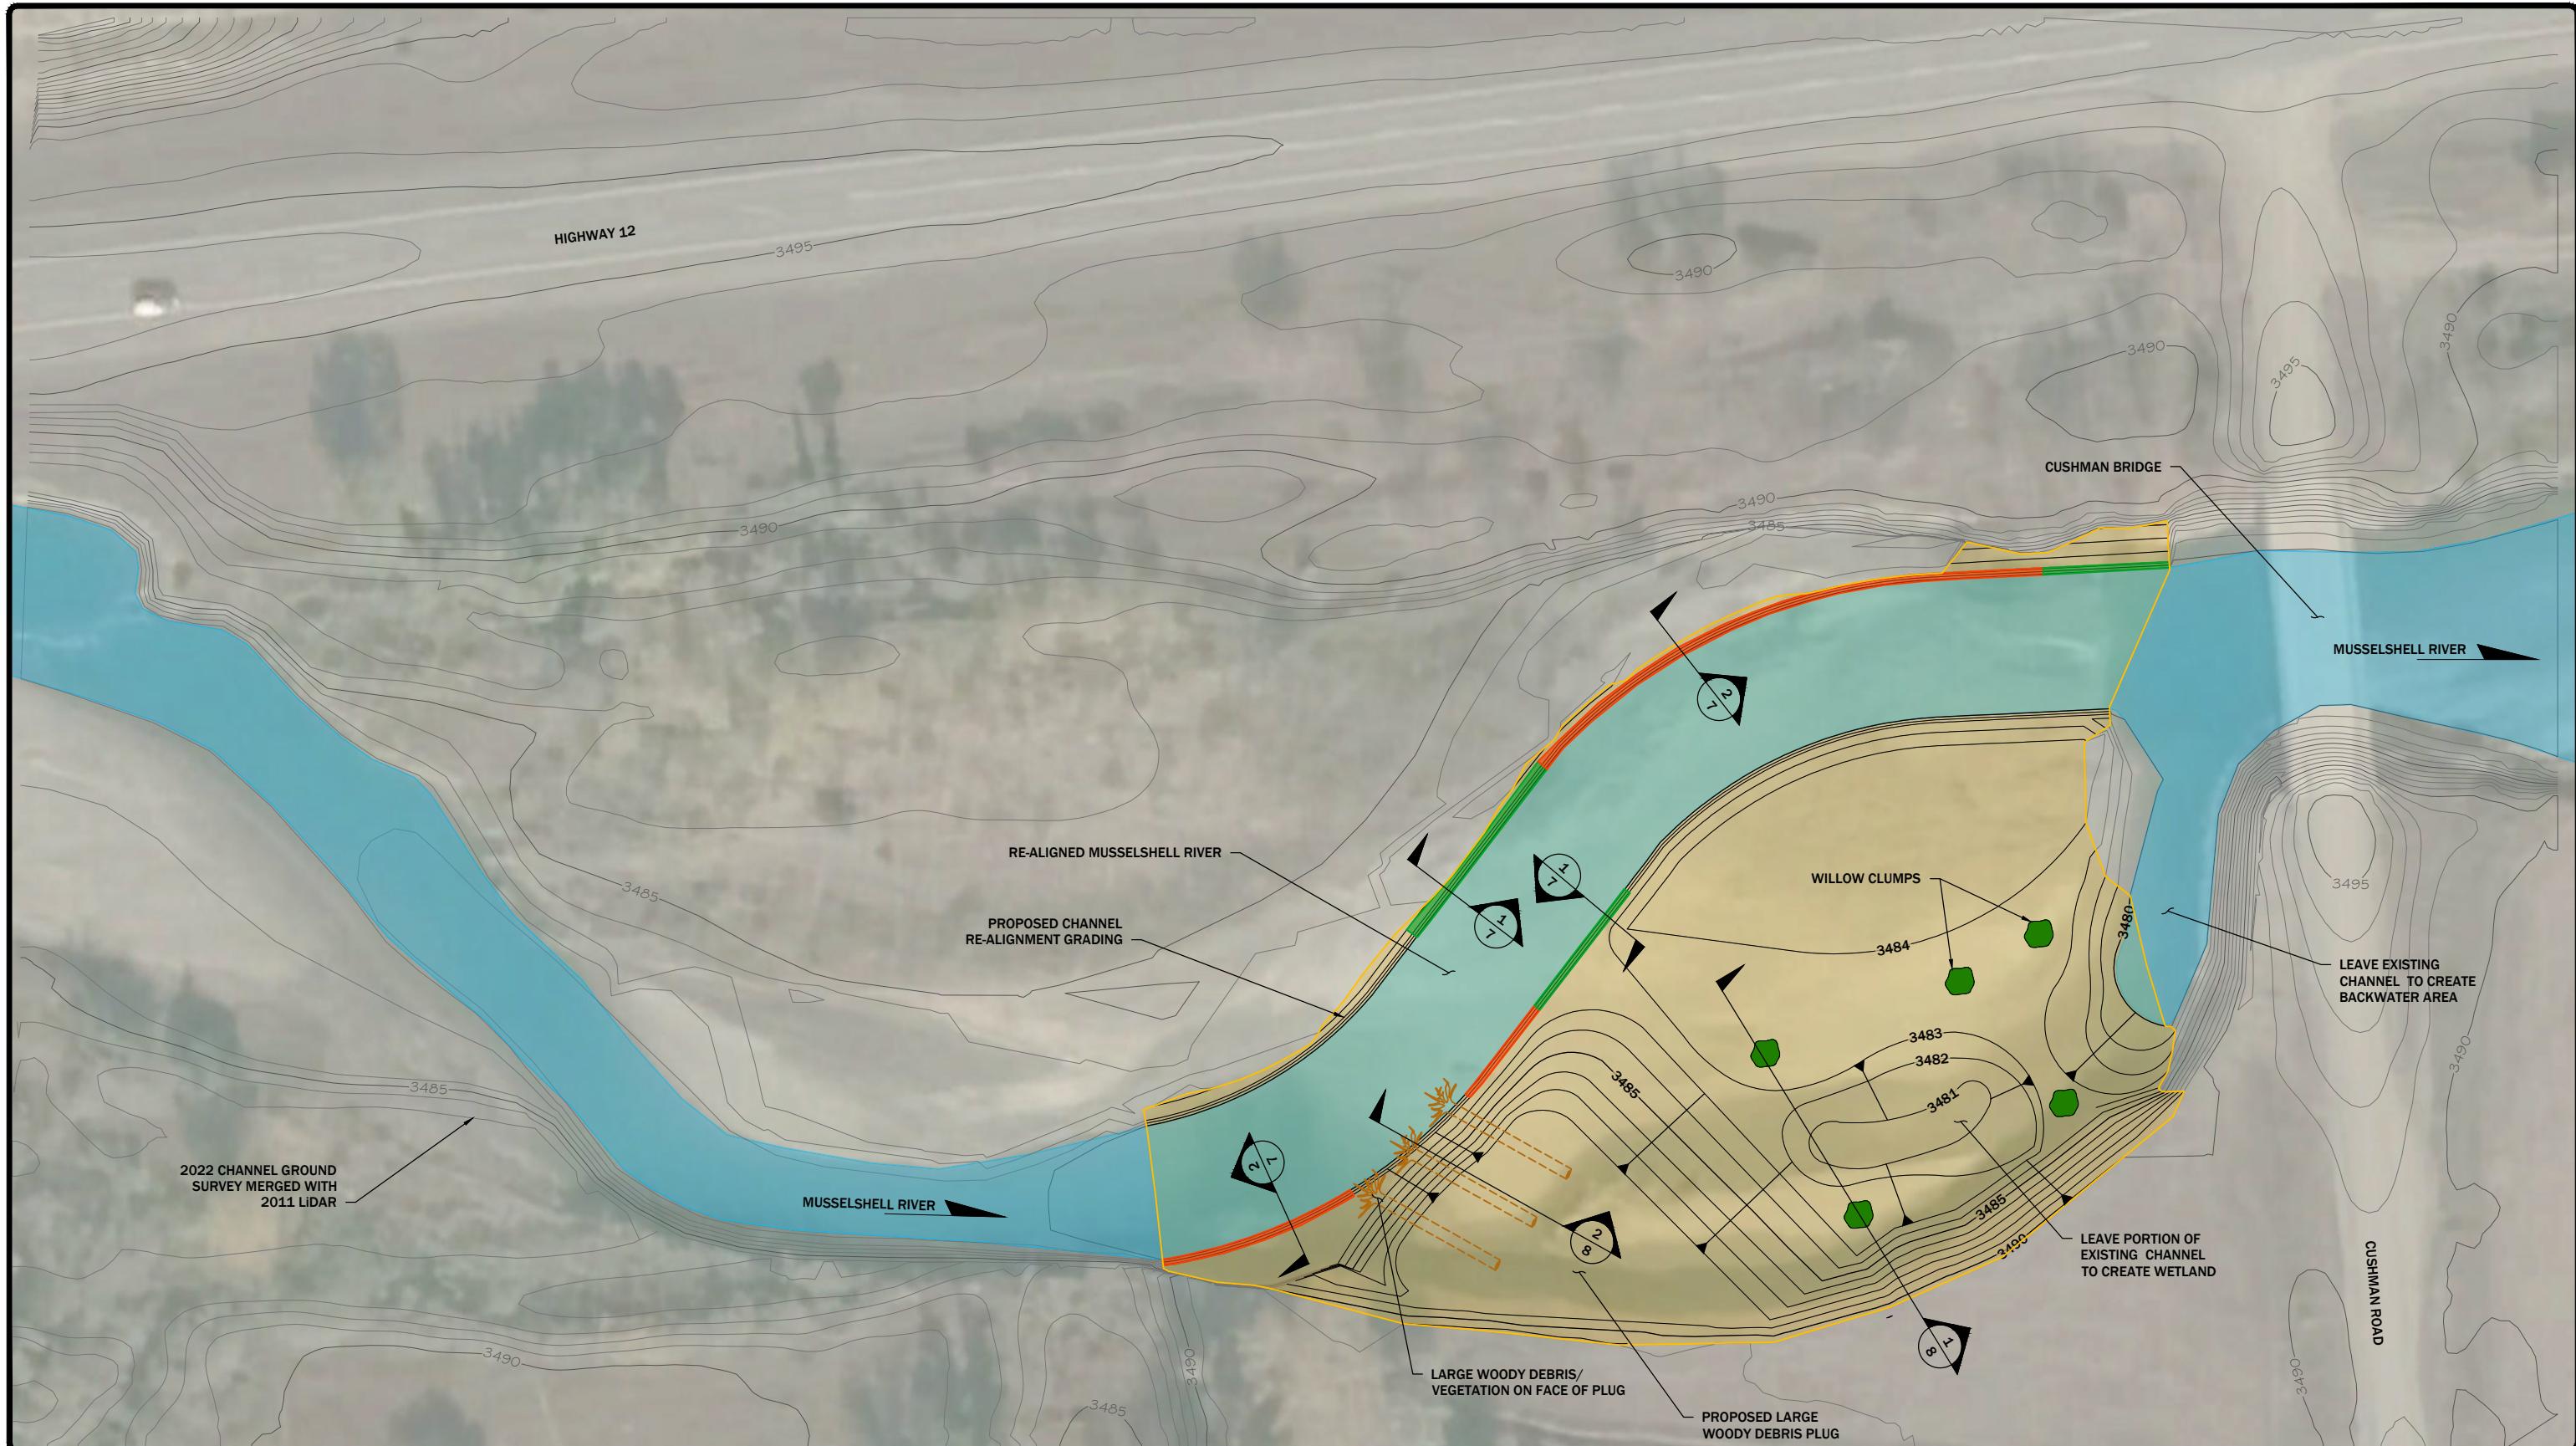
FIGURE 6

TYPE 1 BANK TREATMENT

TYPE C BANK TREATMENT

TYPE 2 BANK TREATMENT

CUSHMAN BRIDGE BANK RESTORATION ALTERNATIVE 2 PLAN VIEW

The second alternative would realign the river back into the abandoned channel with the use of a large woody debris plug and new channel banks would be constructed using the brush matrix bank treatment (Figure 6).

For the second alternative approximately 500 feet of channel will be re-constructed to realign the channel to the pre-2011 channel alignment. A brush matrix bank treatment will be installed on both relocated channel banks where erosive forces are expected to occur. The existing cut bank would be graded and seeded. Additional detailed survey and analysis will be required for final construction level design.

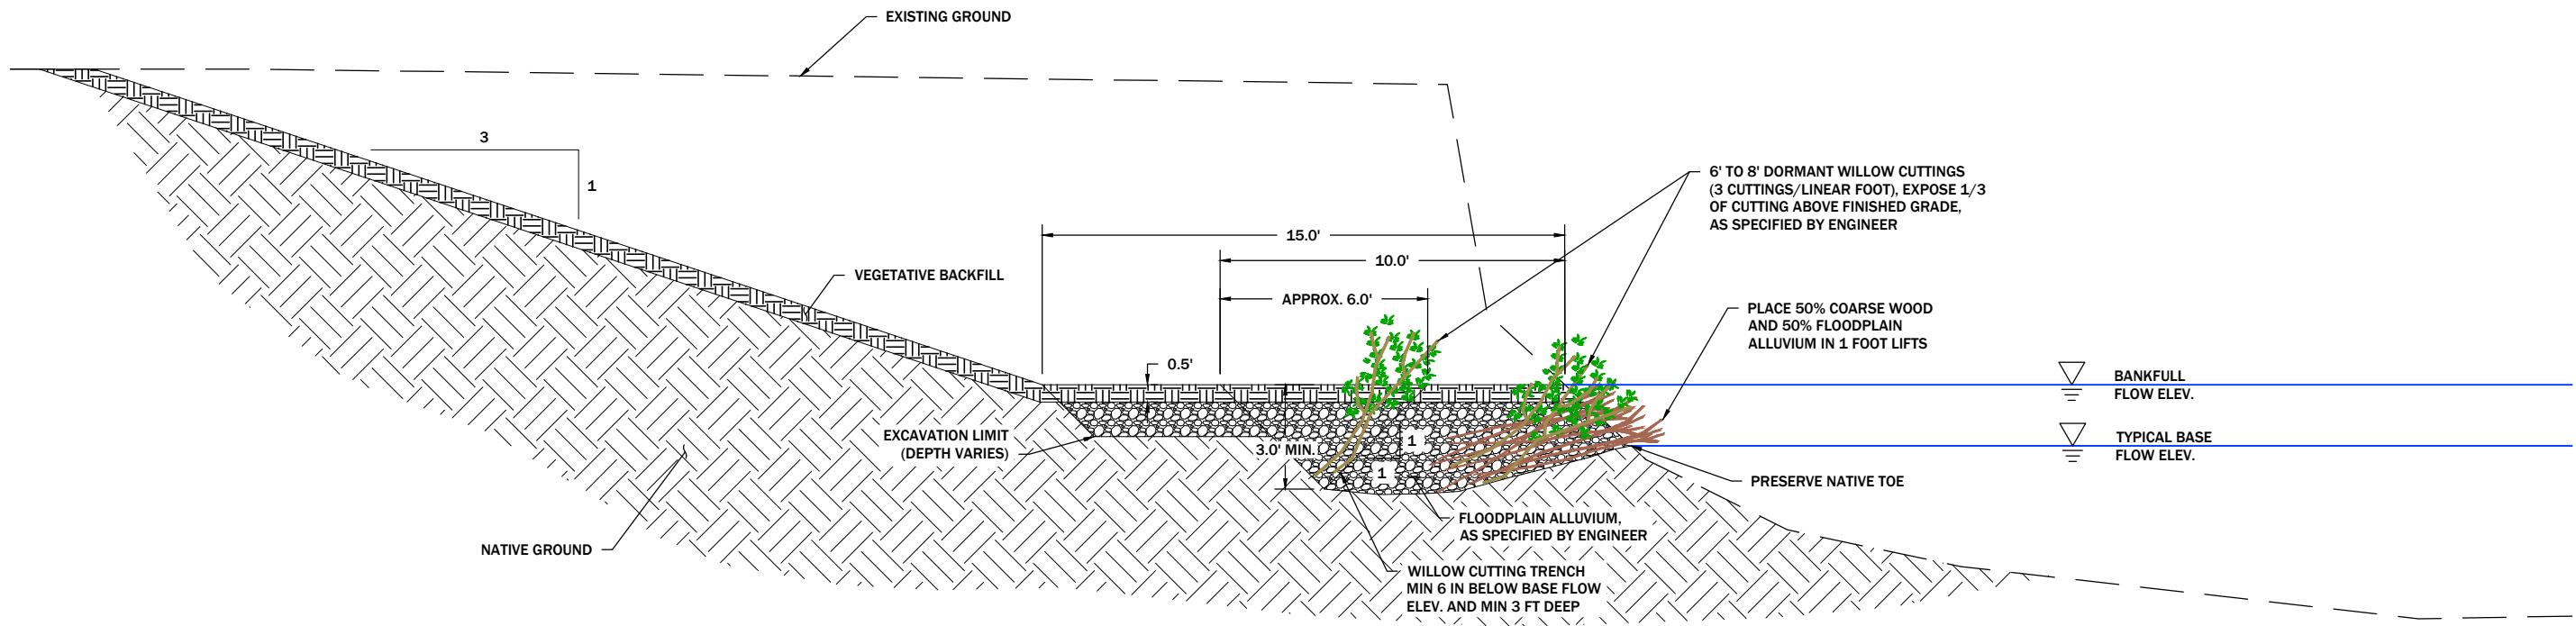
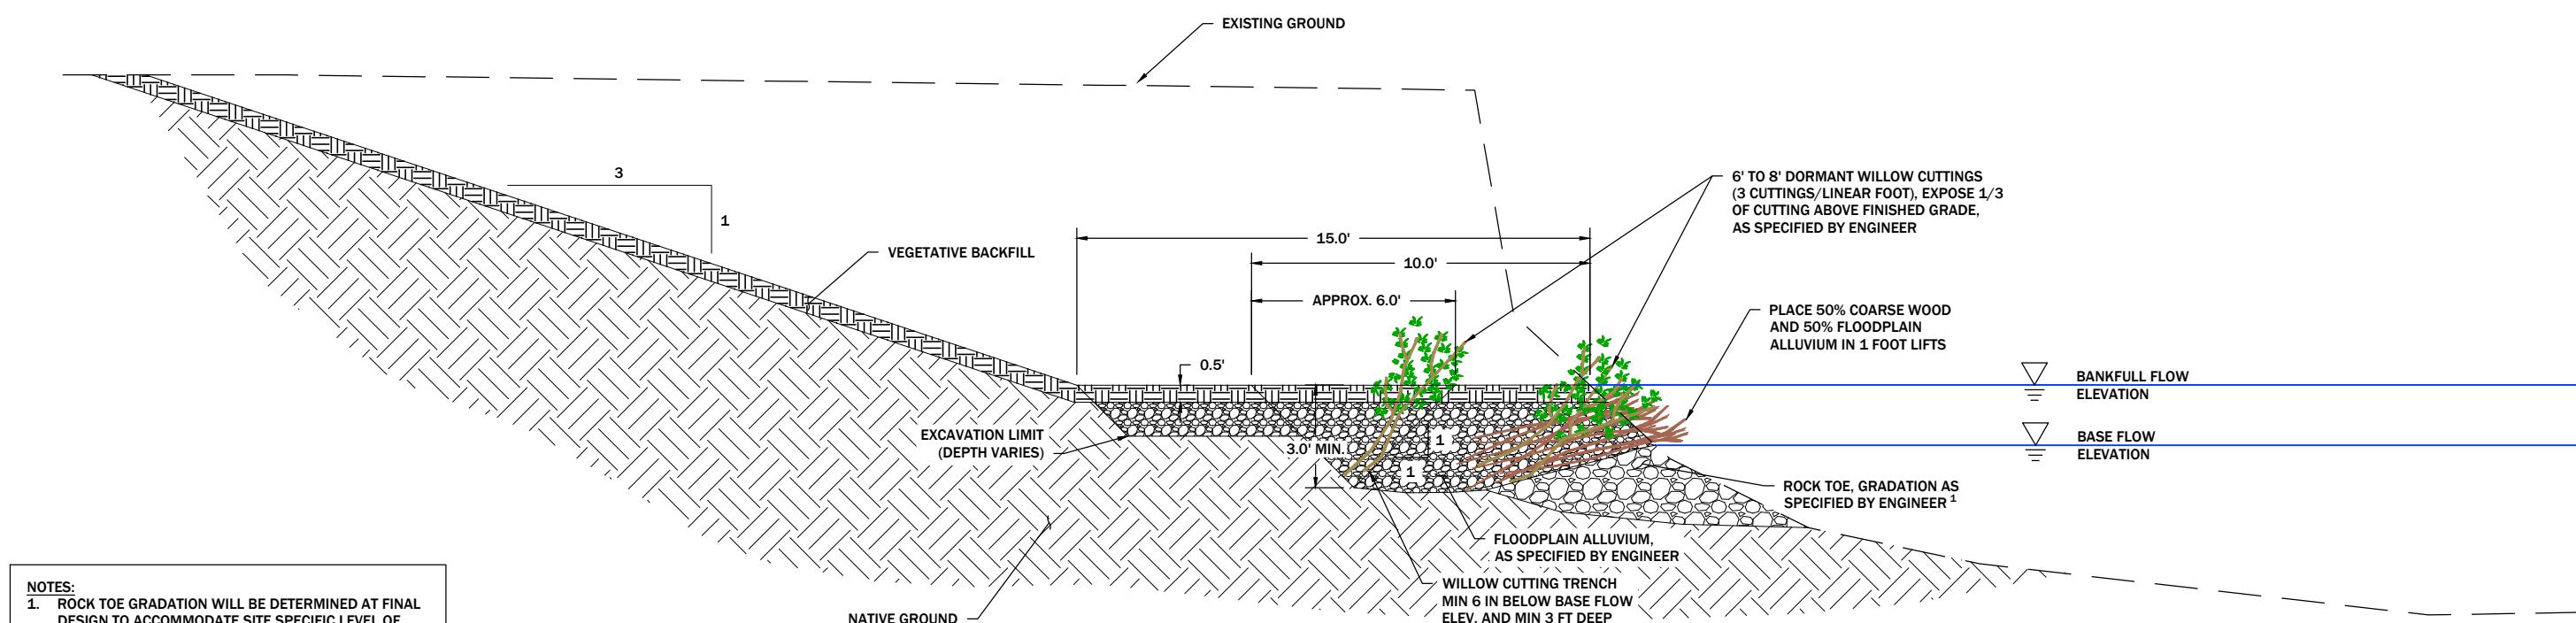
BRUSH MATRIX
BANK TREATMENT
TYPICAL SECTIONS

A brush matrix bank treatment consists of constructing a new channel bank with coarse alluvium, dormant willow cuttings and woody debris (branches, roots, or small trees not expected to grow). Once the willow cuttings have been established, they will increase roughness by providing riparian vegetation within the floodplain and streambank. This vegetation will improve bank stability and provide shade/cover, improving aquatic habitat. The woody debris adds roughness to the bank, reducing erosive forces until the willows are established. As part of the brush matrix bank treatment a bench 10-15 feet wide will be constructed at the floodplain elevation to provide additional floodplain conveyance capacity. This bench will be planted with willow cuttings to add floodplain roughness during out of bank flood events. Finally, grading the cut bank to a milder slope and vegetating will provide a more geotechnically stable slope that is easier for vegetation to become established and will help to reduce erosion during flood events.

The brush matrix bank treatment is designed to be constructed to bankfull flow elevation. The brush matrix and bench will be planted with locally harvested willows and the slope will be planted with native grasses. The proposed bank design was based on April 2022 GPS survey data, 2011 LiDAR, and site observations.
