Technical Memorandum

To: Musselshell Watershed Coalition
From: Jon Jupka, P.E., CFM
CC: Karin Boyd and George Austiguy, P.E.
Date: 6/3/2022
Re: Rowton and Cushman Bridge Preliminary Engineering Report

Rowton Property Bank Restoration

Cushman Bridge

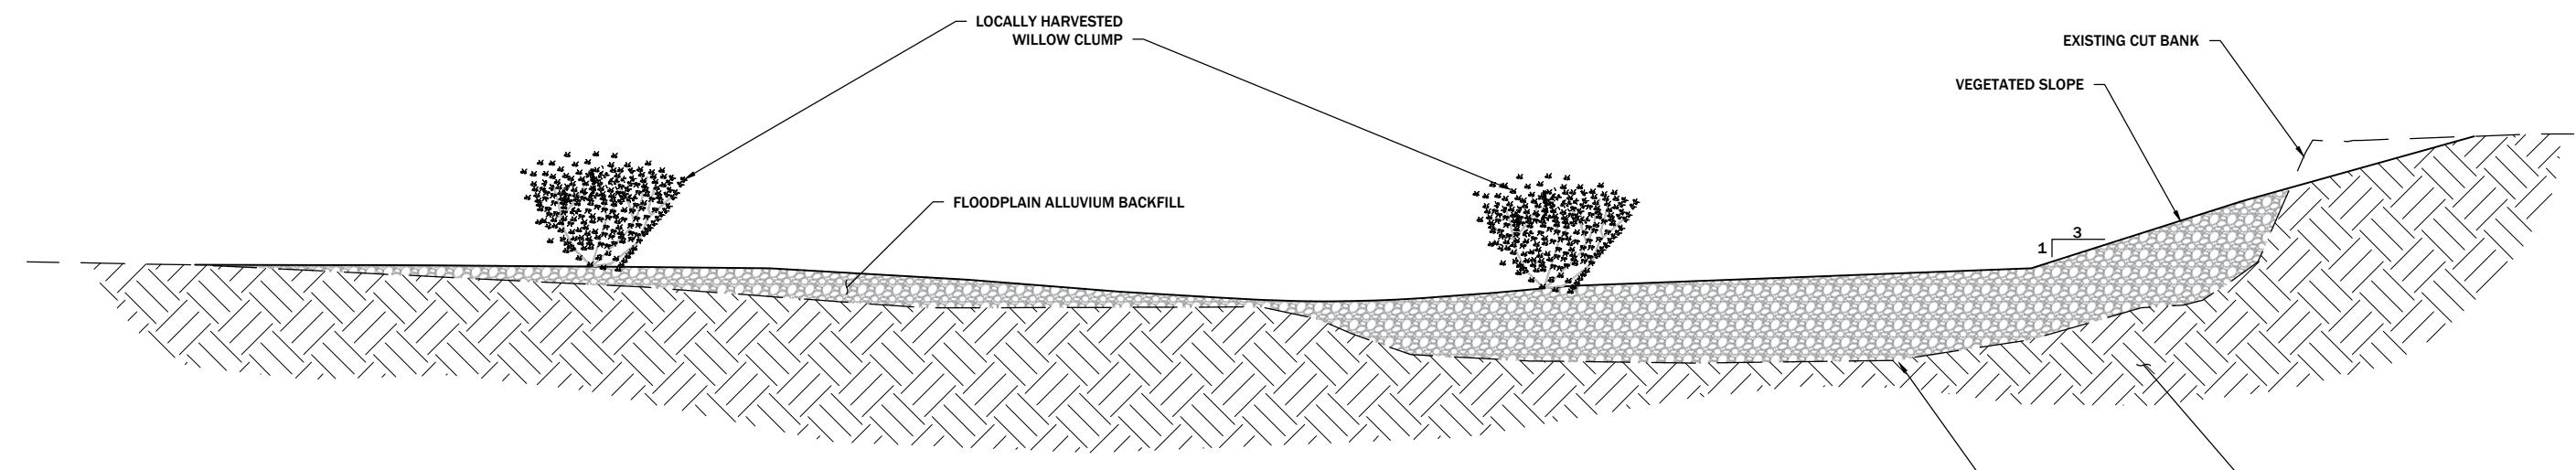
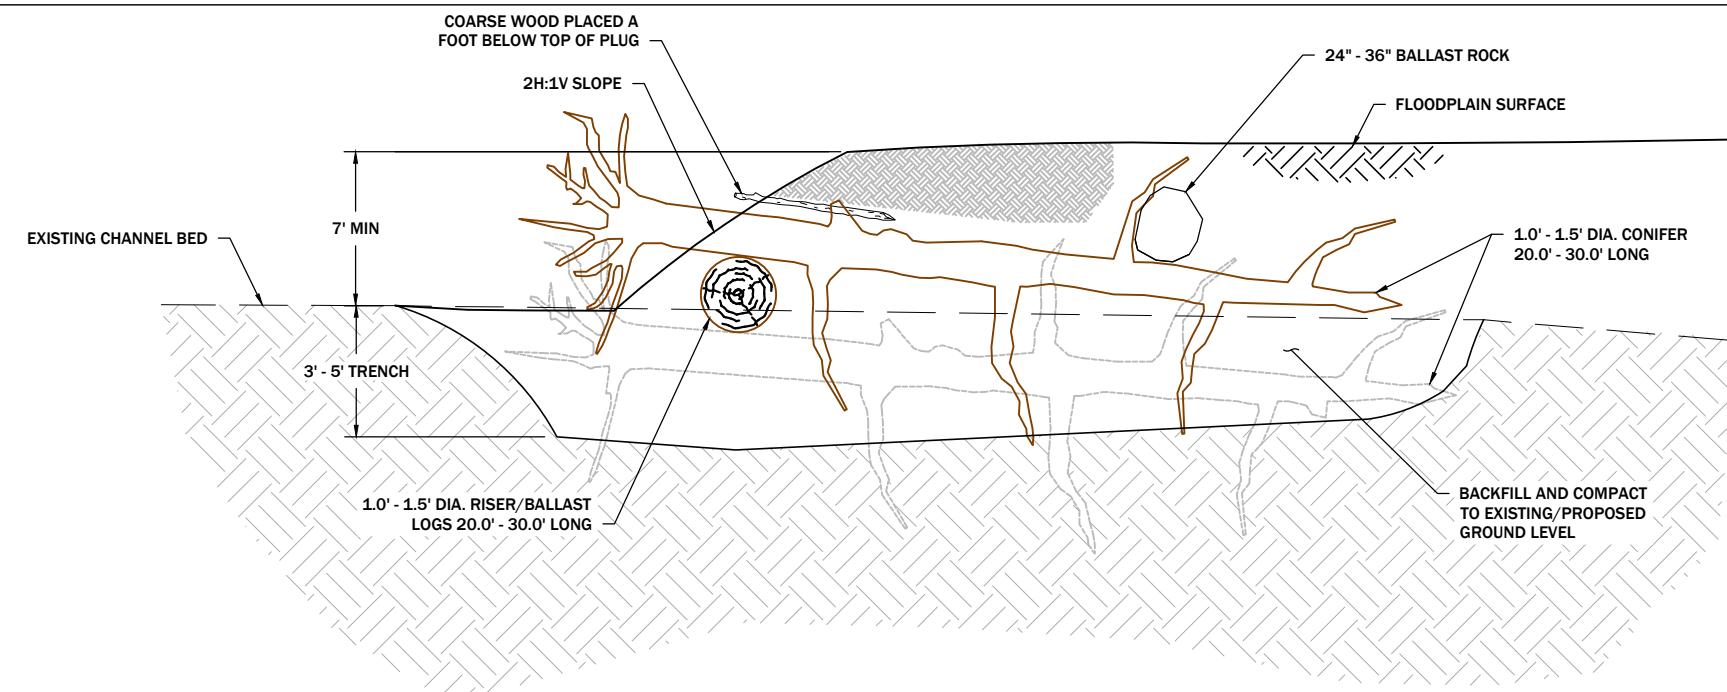
FIGURE 8
PIONEER
TECHNICAL SERVICES, INC.
www.pioneer-technical.com
(406) 782-5177

FLOODPLAIN GRADING **1**
TYPICAL SECTION **6**
N.T.S.

LARGE WOODY DEBRIS PLUG **2**
TYPICAL SECTION **6**
N.T.S.

CUSHMAN BRIDGE
FLOODPLAIN
GRADING AND
LWD PLUG
TYPICAL SECTIONS
DATE: 6/01/2022

A large woody debris plug is an embankment placed in the active river channel to divert the flow into a newly constructed or re-activated channel. Large logs and/or root wads will be partially embedded within the embankment with the root ball side exposed to the river (Figure 8). The roughness from the woody debris provides habitat and reduces the erosive forces on the plug to help establish the new channel.

Excess material from the re-activated channel excavation will be placed in the current active channel to create a floodplain and wetland areas. Locally harvested willow clumps (large, salvaged willow plants) will be placed in the new floodplain. The existing cut bank to the south will be graded back to a 3:1 slope and seeded to reduce the chance of additional erosion during large flood events. Both proposed alternatives were based on April 2022 GPS survey data, 2011 LiDAR, and site observations.
