FINAL Report

June 2022

# Musselshell River Watershed Plan

## “Vision 2030”

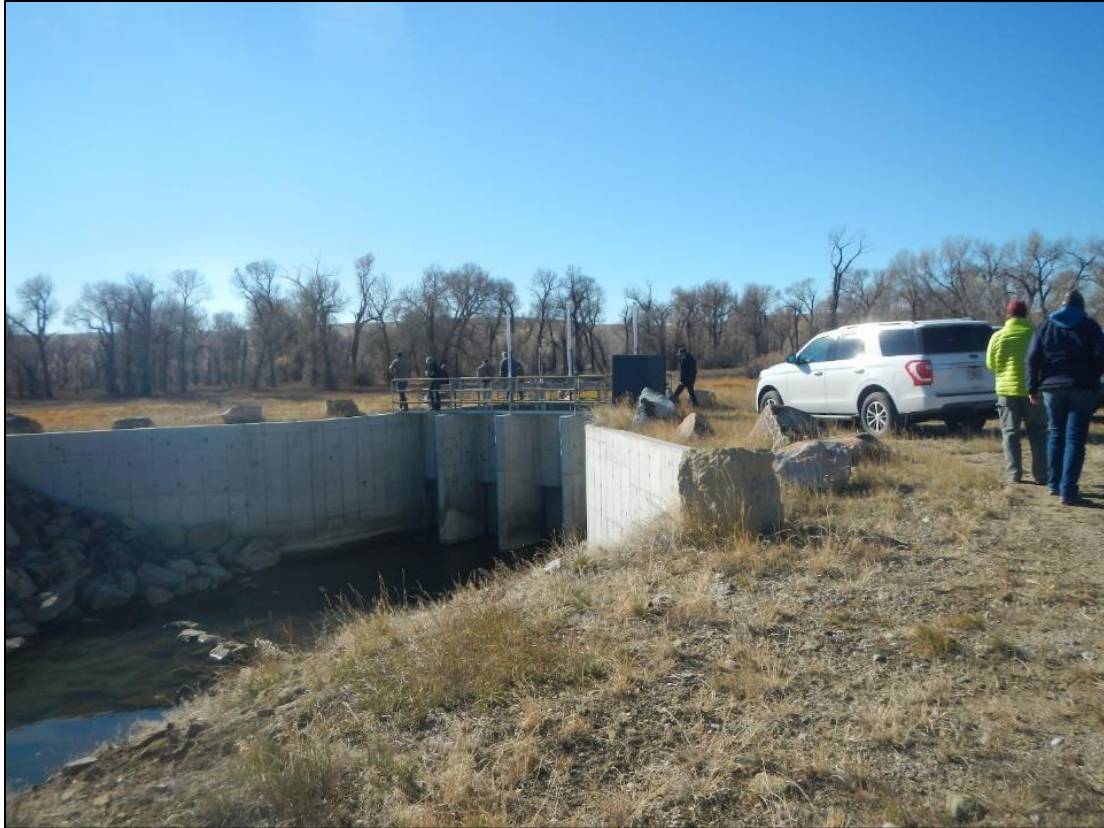
**Figure 5. Reconstructed headgates at Deadman's Basin Diversion Dam (2021).**

The 2011 flood severely damaged the diversion dam and headgates at the Deadman's Basin Diversion Dam which is located at RM 278.4 between Harlowton and Shawmut. The alternatives considered to repair the dam included restoring the existing structure, replacing the existing structure with the same design, or installing a new grouted riprap Rock Ramp structure. The Rock Ramp was chosen for its long-term stability, elimination of downstream scour problems, and better accommodation of safe operation, fish passage, and river connectivity (Hice, 2016). The design also incorporated the replacement of the diversion headgates which did not fully close, resulting in an infiltration loss of an estimated 3,000 acre-feet of water per year into the 11-mile long canal (Figure 5; MTFWP, 2016). The leaky headgates and dam were rehabilitated starting in August 2015. The project includes a gated sluiceway to flush sediment, four new stainless steel gates, and an electric actuator. Additional funding was secured to add a rock ramp to the dam face to provide fish passage over the structure. The passage structure consists of a rock ramp on the downstream face of the dam that has a step-pool morphology to provide areas for resting and jumping (Figure 6). Evidently construction crews saw trout move through the ramp immediately after it was opened to flow (FWP, pers. comm). The final cost of the project was just over \$1 million (Hice, 2016).

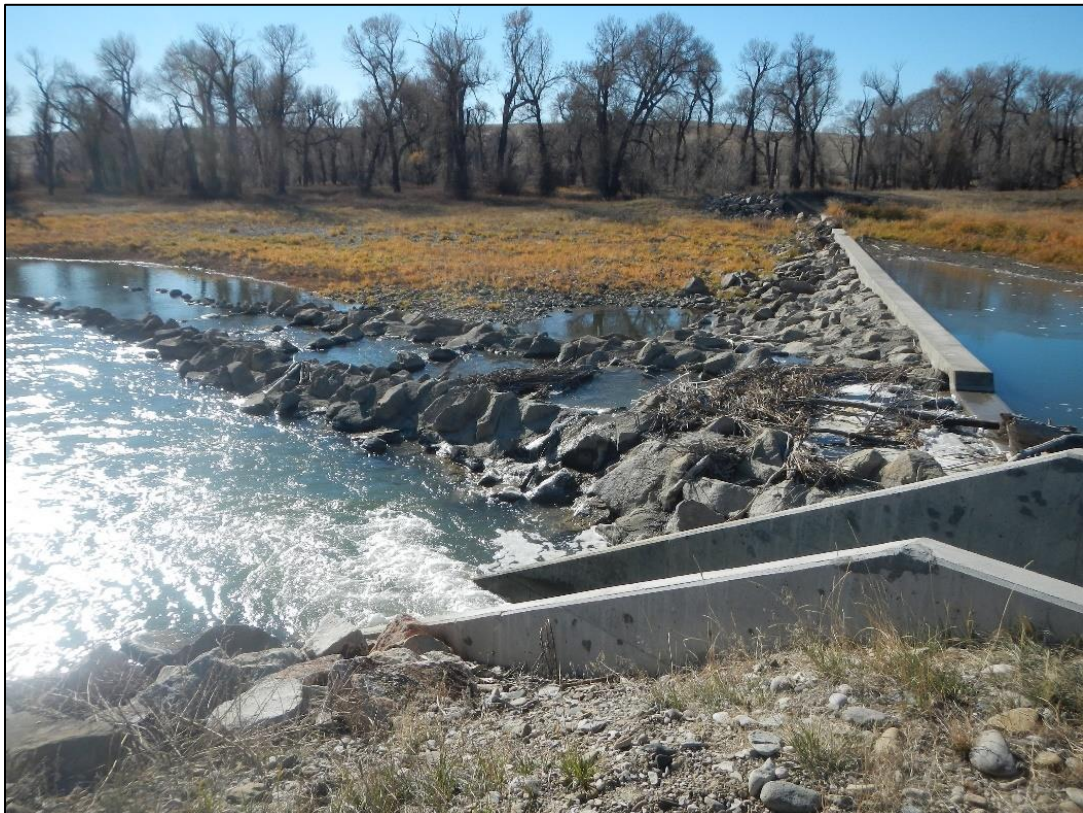
**Figure 6. Rock ramp structure on downstream face of Deadman's Diversion Dam built in 2015.**

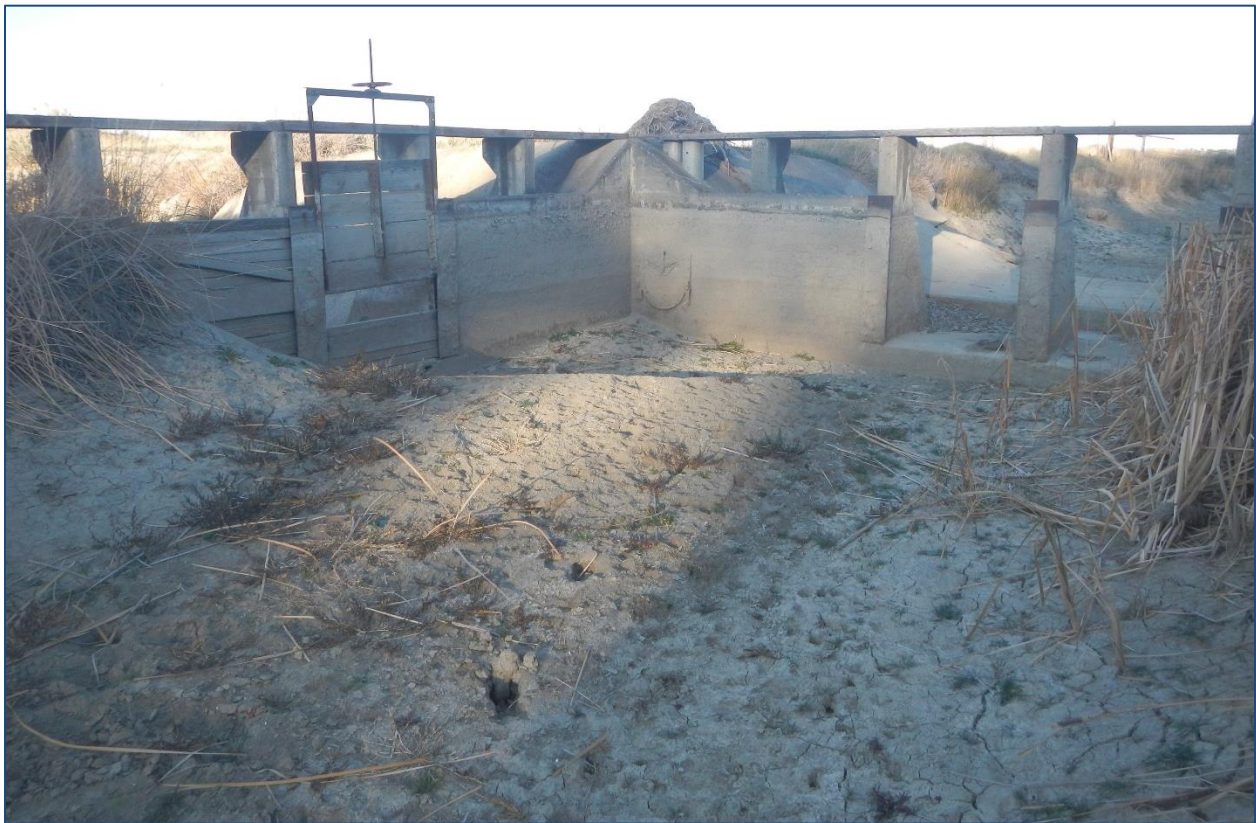
**Figure 7. Manually operated headgate where North Canal (left) splits off from South Canal; this site is slated for automated measuring devices, telemetry, and gate automation.**

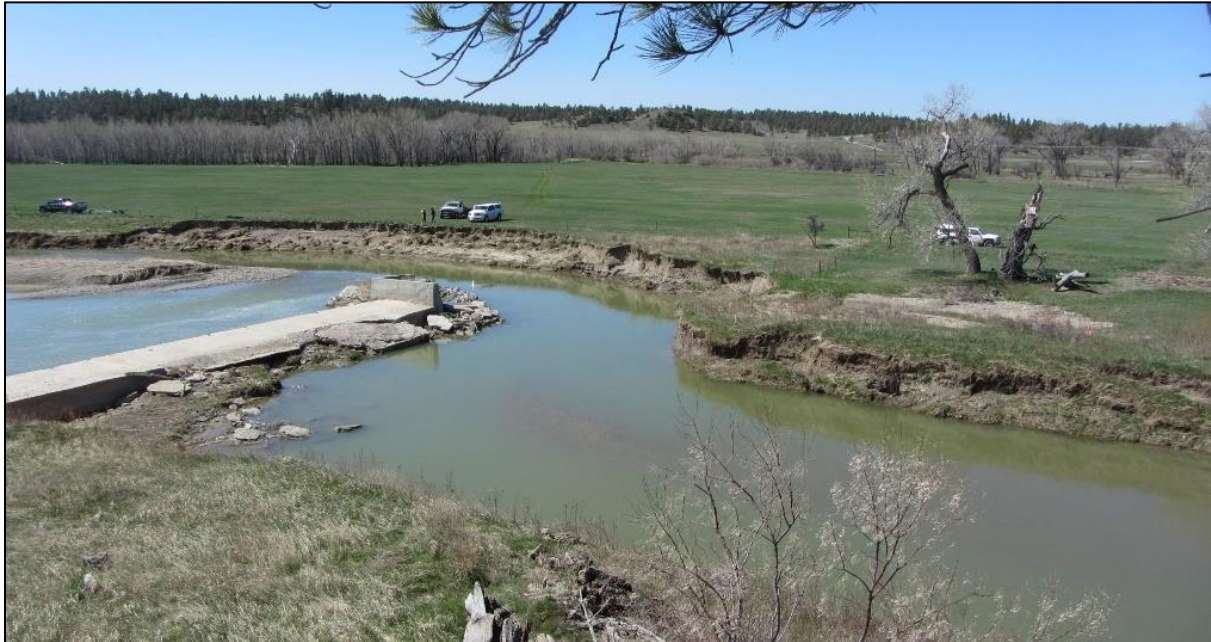
**Figure 9. View downstream of Egge Dam after being flanked by 2011 flood (Allied Engineering).**

Another fisheries-driven project completed recently on the Musselshell is the removal of Egge Dam, a diversion dam located about 10 miles downstream of Lavina. The concrete sill dam was flanked on its right (south) side during the 2011 flood (Figure 9). Shortly after it was rendered useless, landowners opted to work with Montana Fish Wildlife and Parks to remove the structure rather than replace it, as the restored connectivity would open up miles of channel to upstream fish migration. The project included removing the 120- foot long concrete structure, filling a large scour hole with over 3,000 cy of

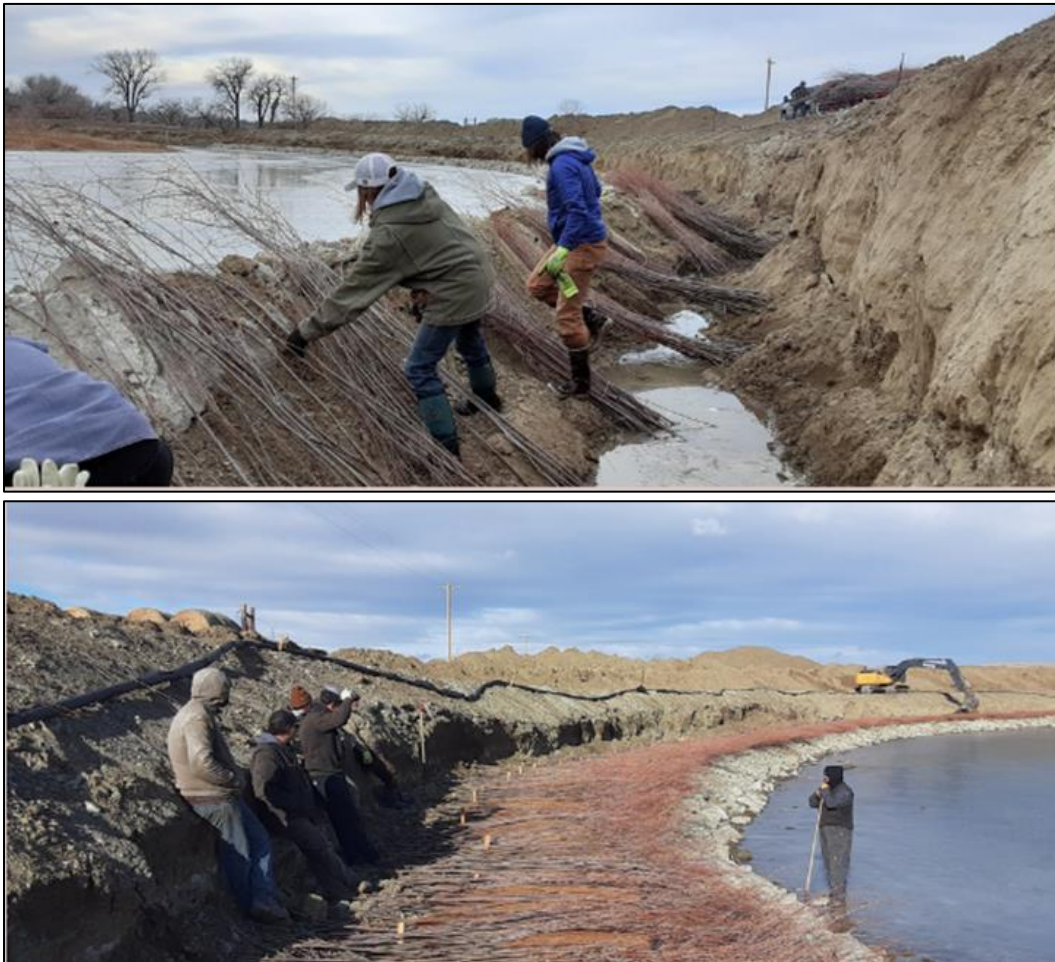
Figure 12. Kilby Butte bank protection during early (top) and late (bottom) stages of construction.

The Kilby Butte bank stabilization project was completed in early 2022 a few miles downstream of Roundup. This project approach was somewhat similar to the Two Dot project described above, however as the site was located immediately upstream of a diversion dam at the toe of a high terrace, some more difficult challenges were in play. First, the ~15 foot tall bank had to be lowered to construct a low platform on which to work. With the high bank and infrastructure protection needs, a non-deformable rock toe was used. This toe was topped with soil lifts and willows (Figure 12).

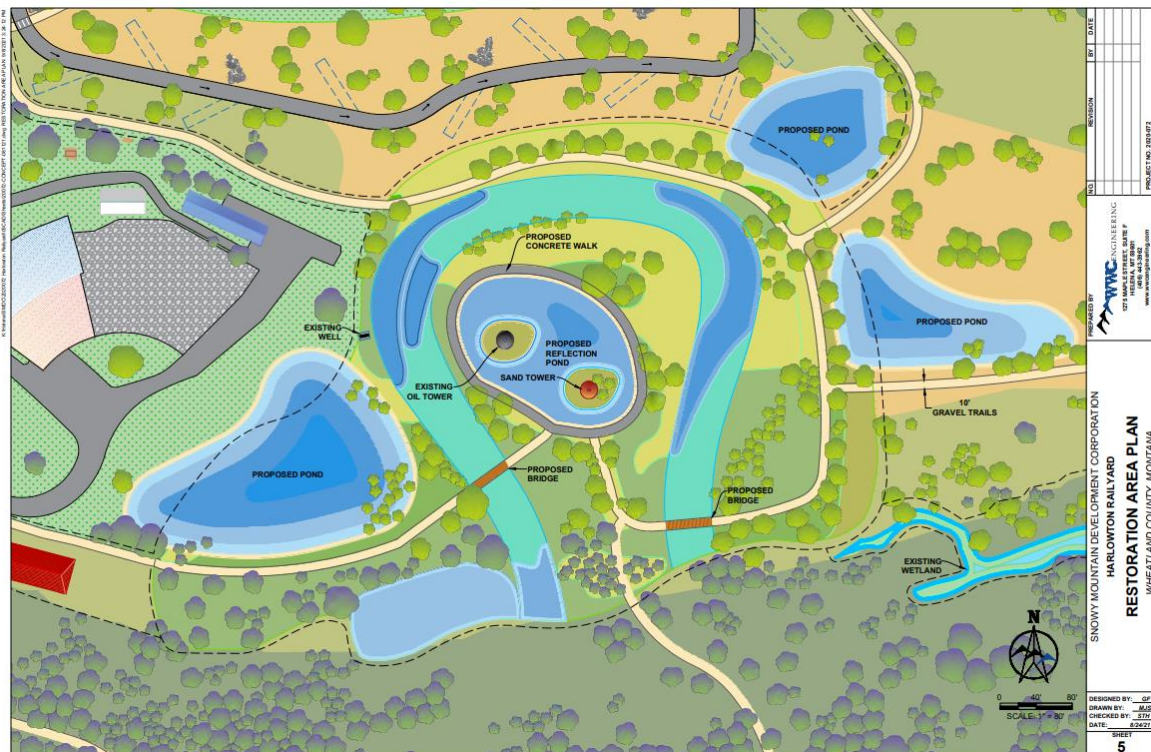
Figure 17. Schematic depiction of Restoration Area from 2021 Concept Plan (WWC, 2021).

The general Restoration Area concept was to restore wetlands within the Musselshell River floodplain by excavating fill and tapping the shallow groundwater source. The wetlands are proposed to mimic a natural abandoned segment of the Musselshell River (Figure 17). Ponds are also included adjacent to the constructed oxbow wetland.

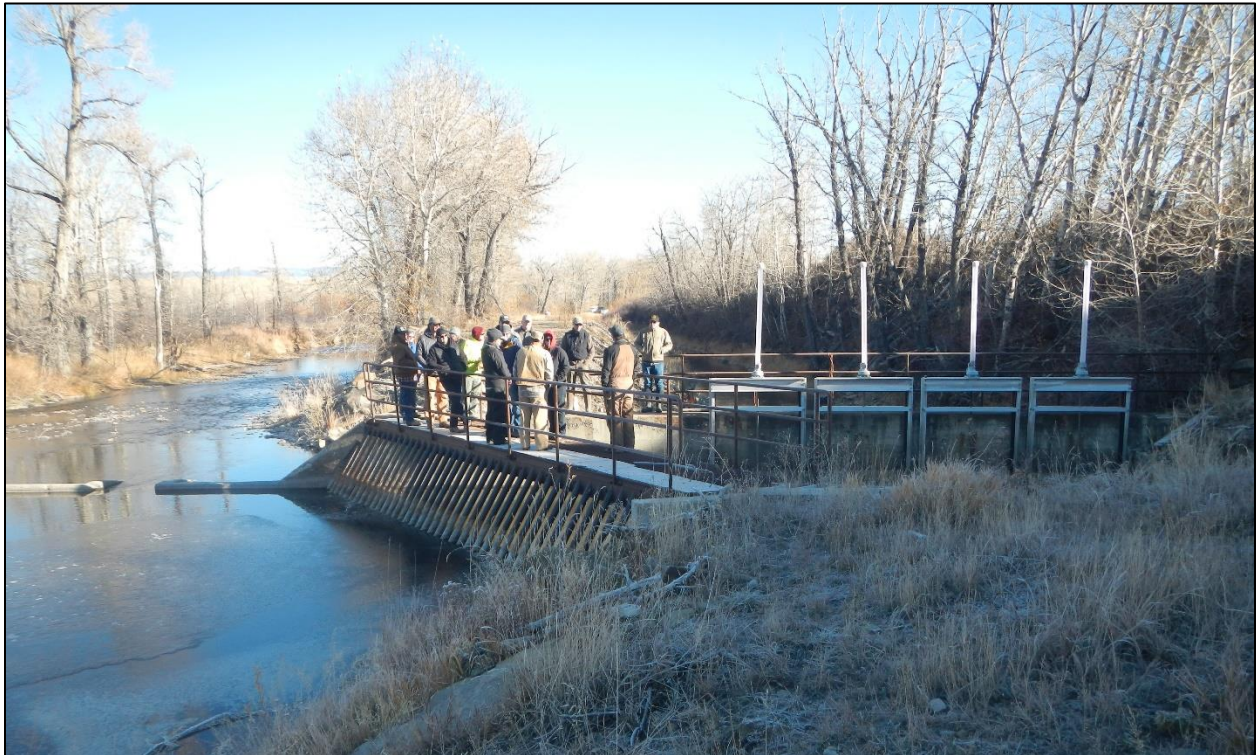
**Figure 31. View downstream of Martinsdale Supply Canal diversion structure on Musselshell River.**

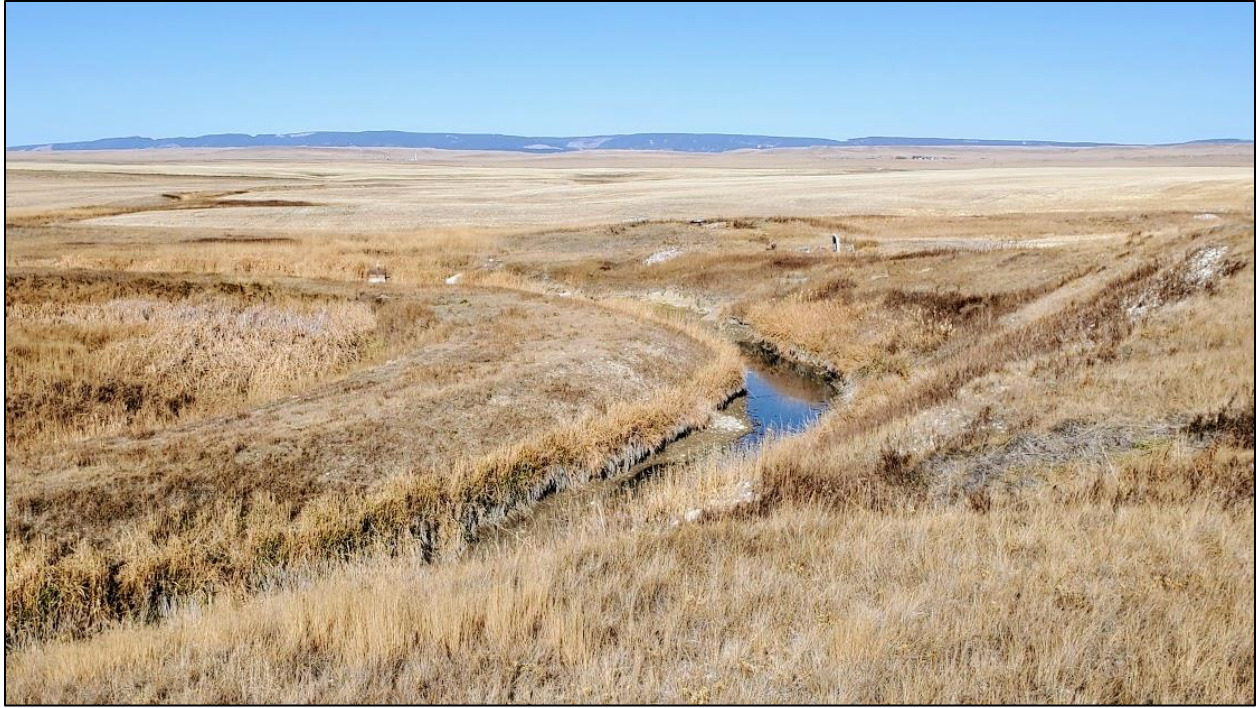
**Figure 32. Two-Dot Canal segment (Mexican John Section) prone to seepage losses.**

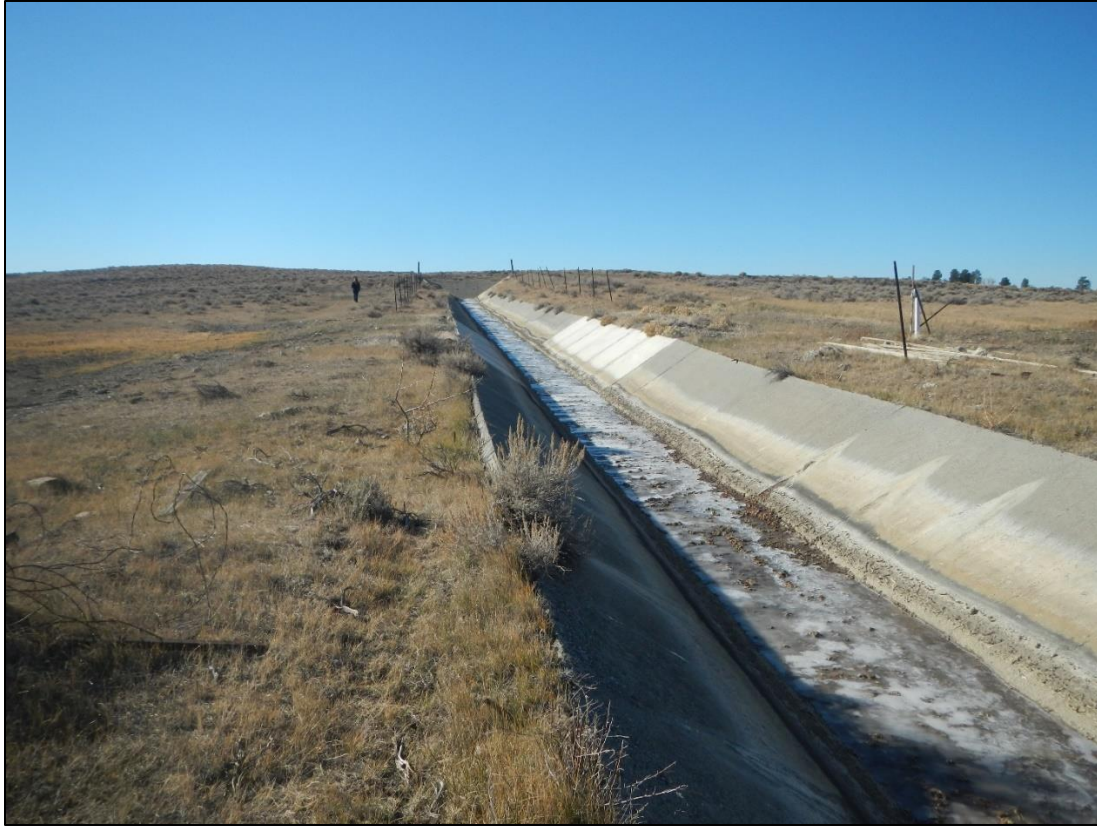
Figure 34. View up-gradient of Careless Canal Drop #3.

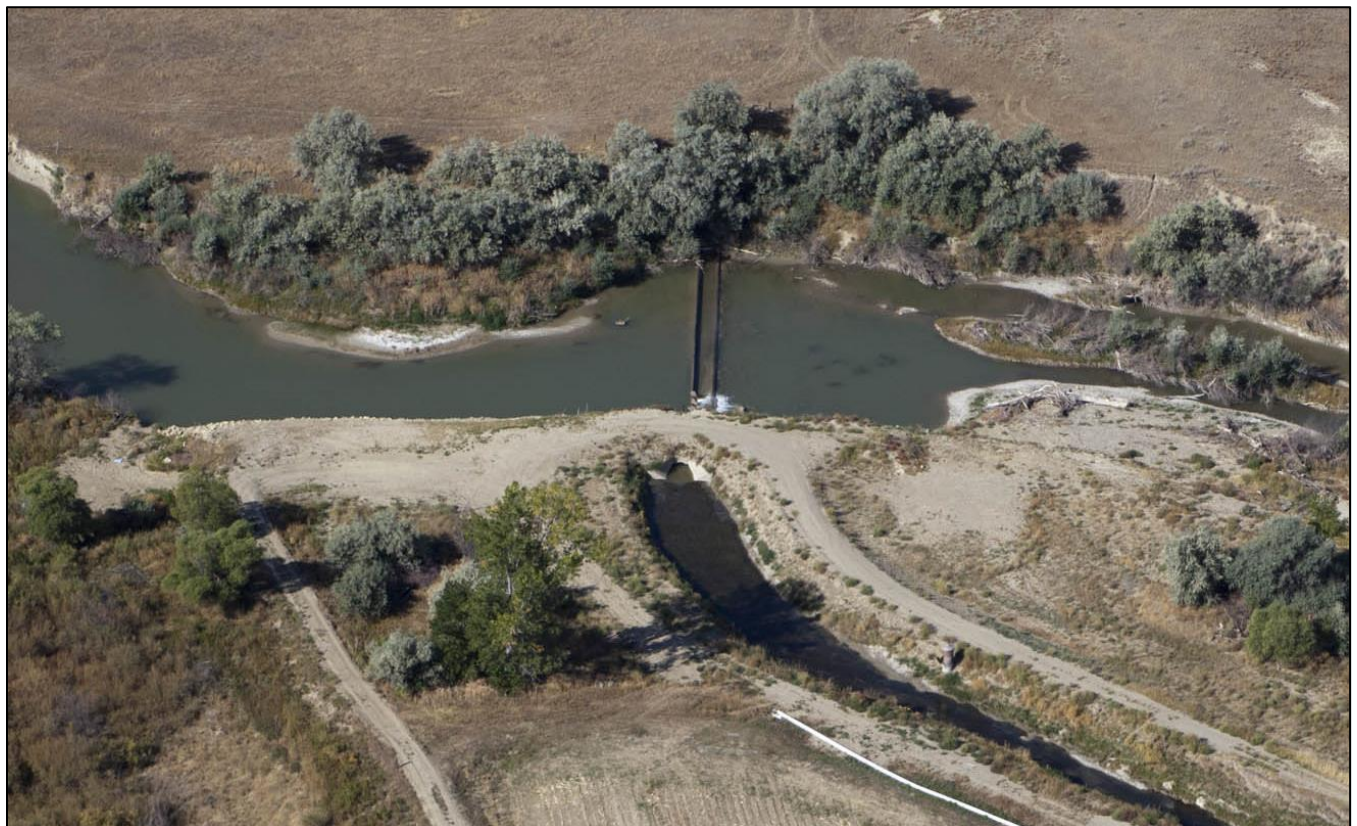
**Figure 36. Delphia Dam and Canal; flow direction is left to right (Kestrel Aerial Services, 2012).**

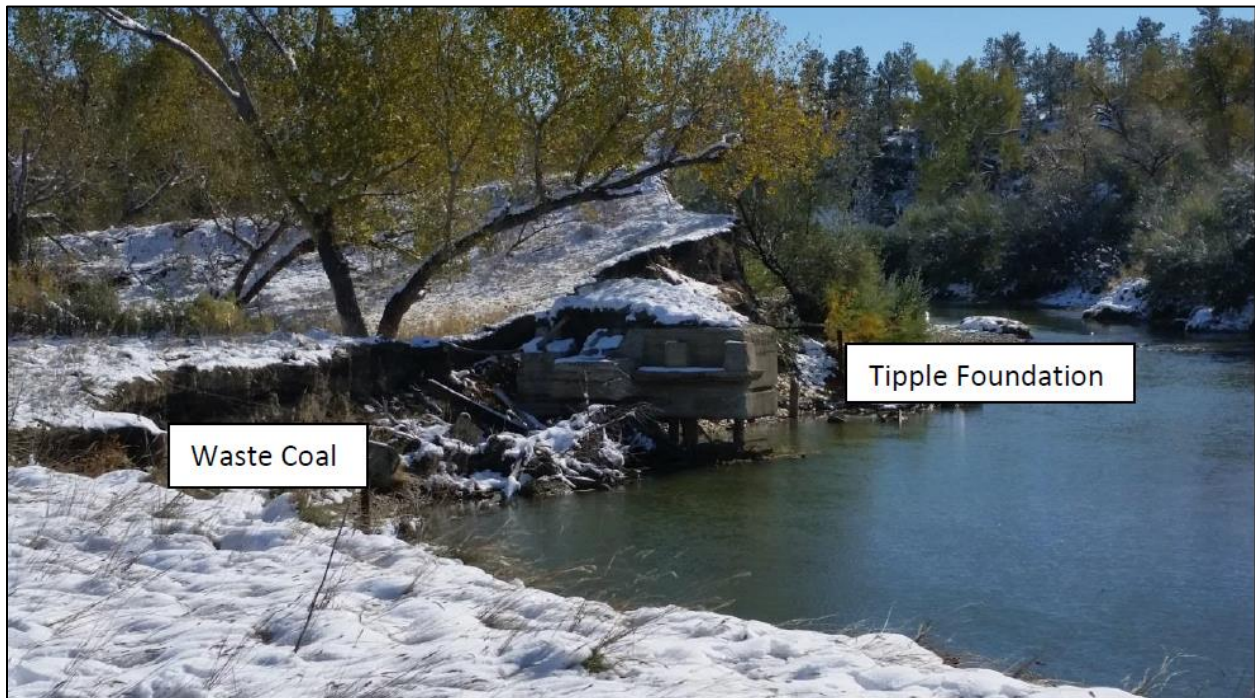
**Figure 41. View downstream of Jeffrey's Tipple following the floods of 2011 and 2014; note the high road prism behind the concrete tipple foundation (MTDEQ).**

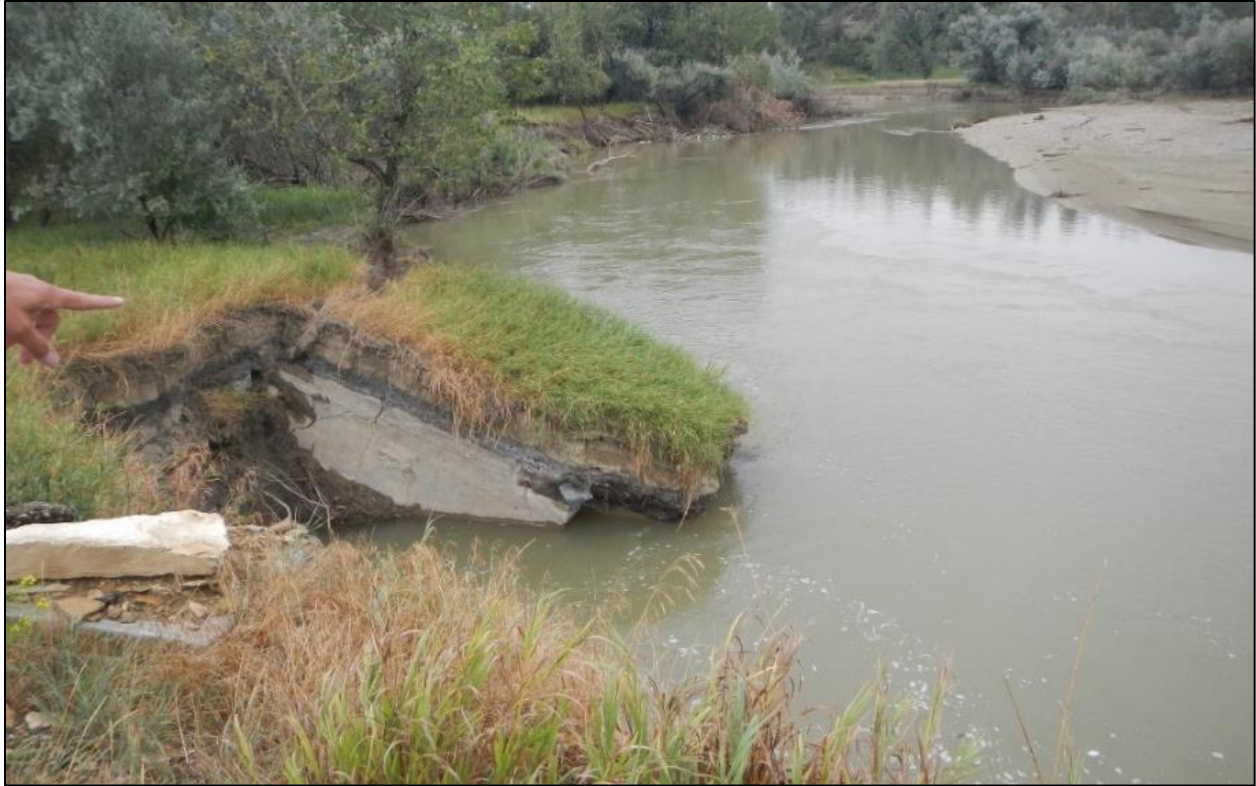
**Figure 42. View downstream following the 2018 flood showing remaining concrete tipple foundation.**

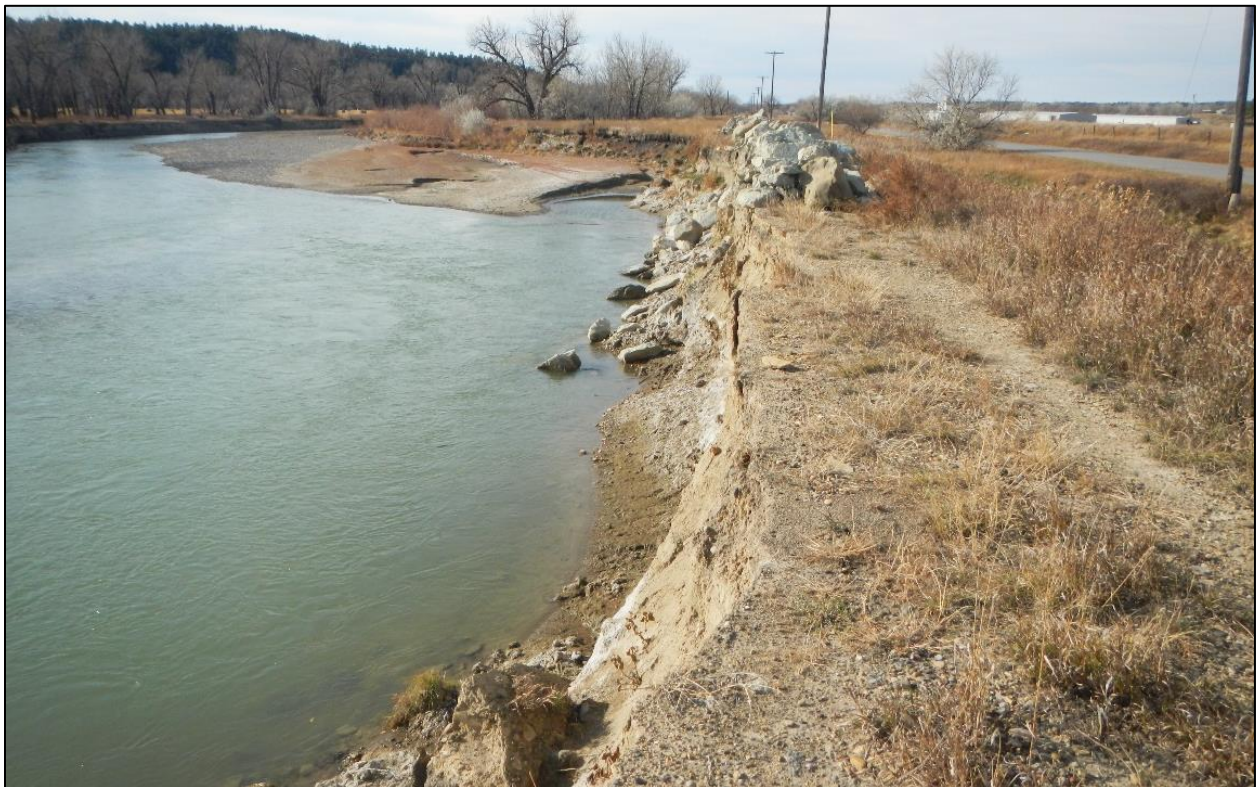
**Figure 43. View upstream from Jeffrey's Tipple showing bank erosion and rock riprap stacked along county road self-launching into channel.**

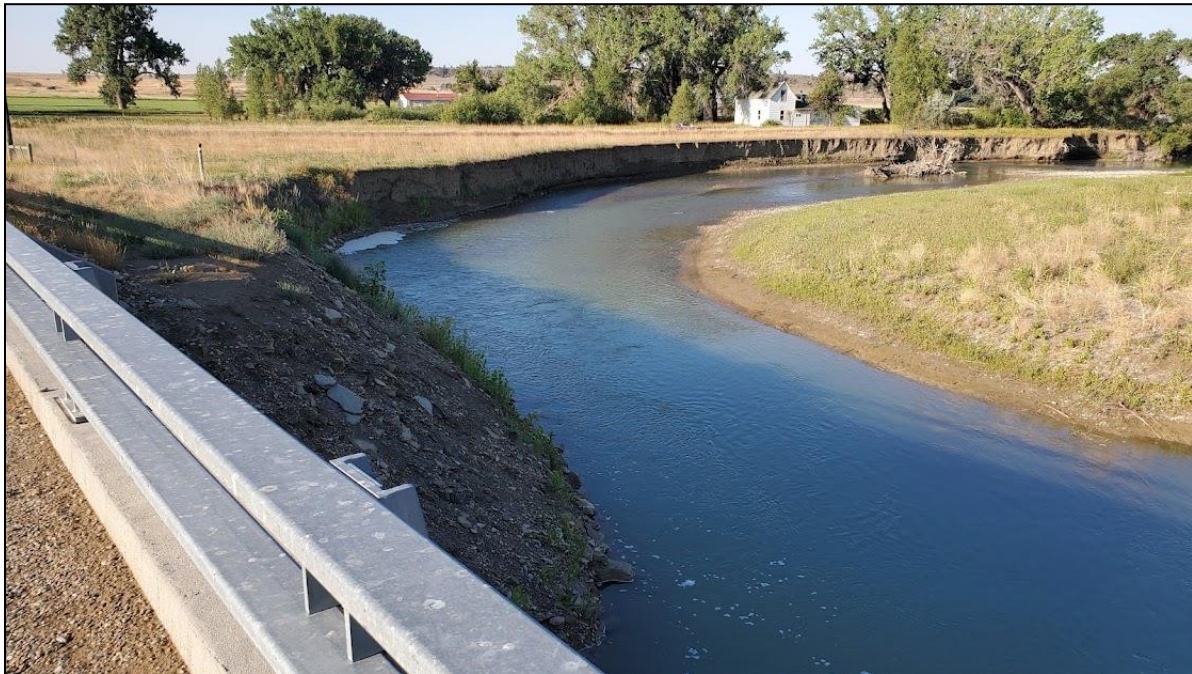
**Figure 45. View upstream from the Cushman Road Bridge showing right bank erosion and current stabilization efforts, August 9, 2021.**

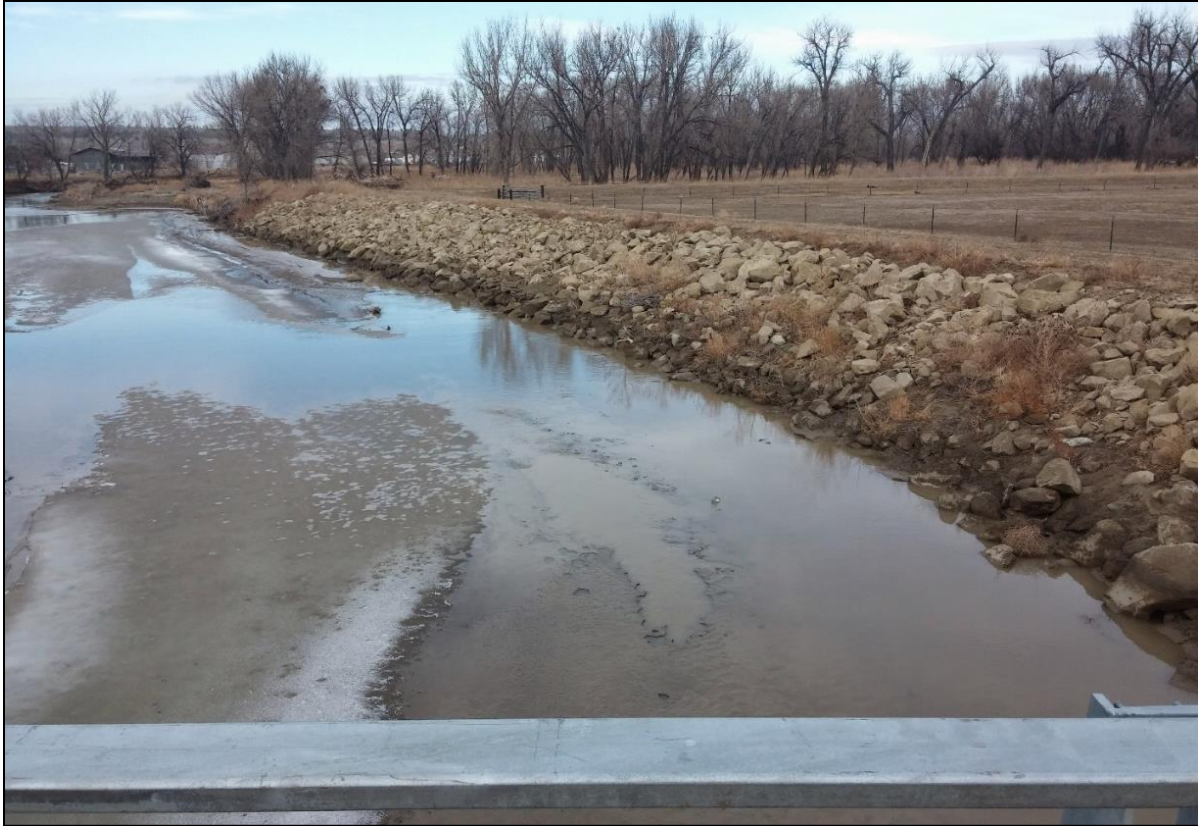
Figure 46. View downstream from 2<sup>nd</sup> Street Bridge showing rocked berm on right bank at Roundup Fairgrounds, February 10, 2015.

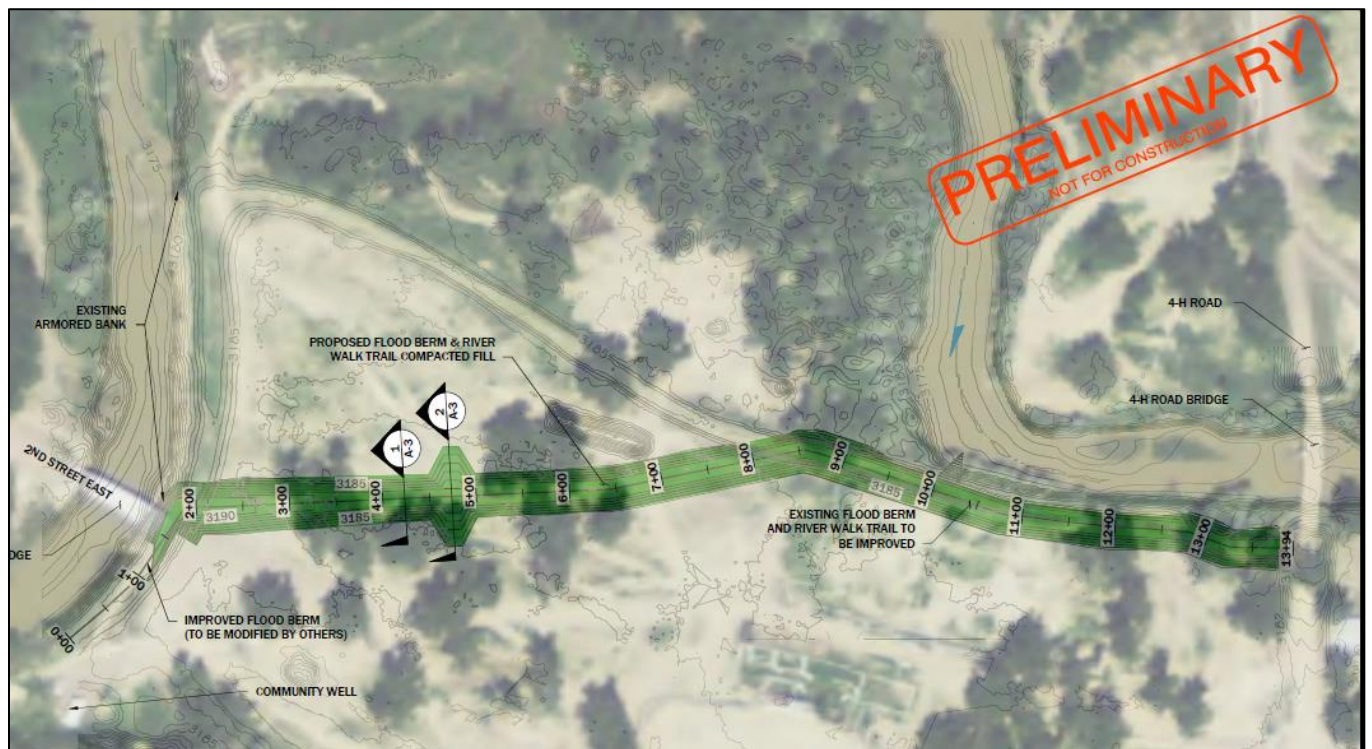
Figure 47. Proposed southward berm relocation (green) at Fairgrounds (Pioneer, 2016).

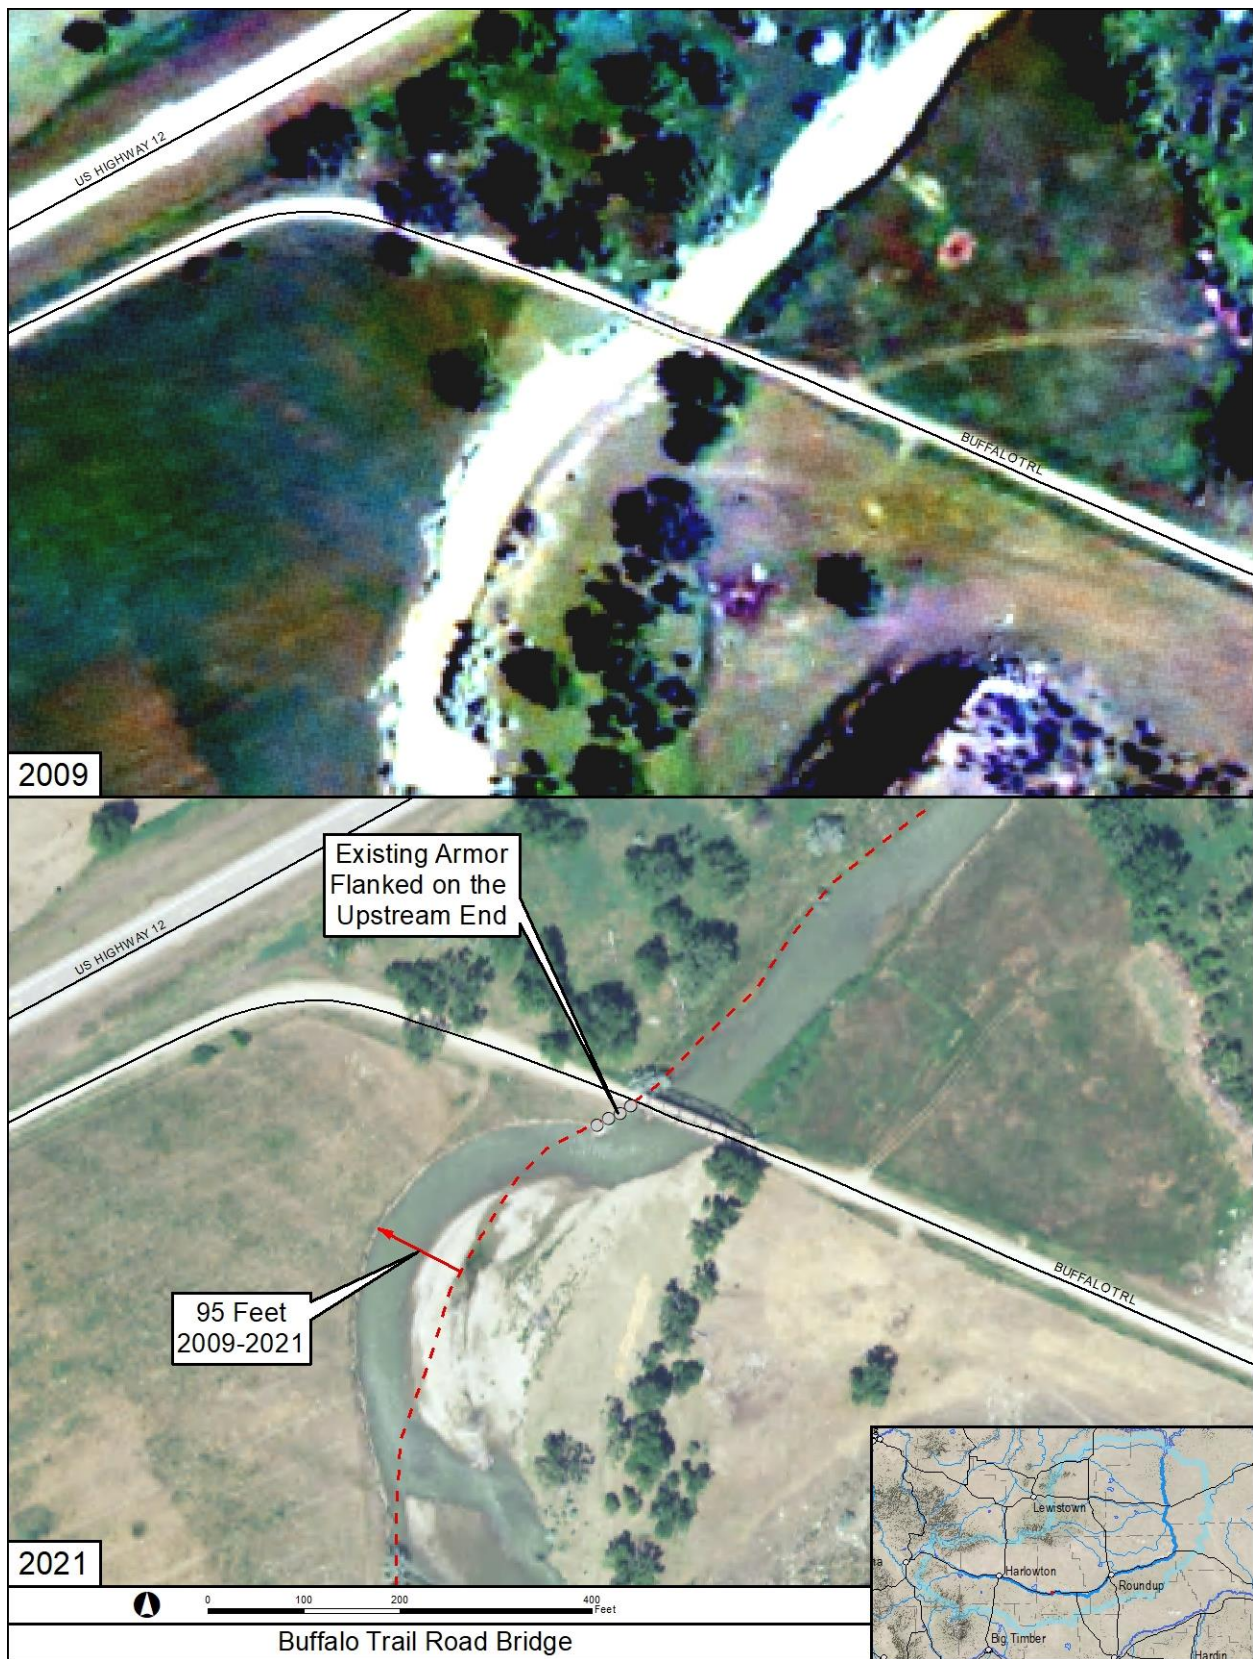
Figure 51. Aerial imagery from 2009 and 2021 showing left bank erosion just upstream of bridge.

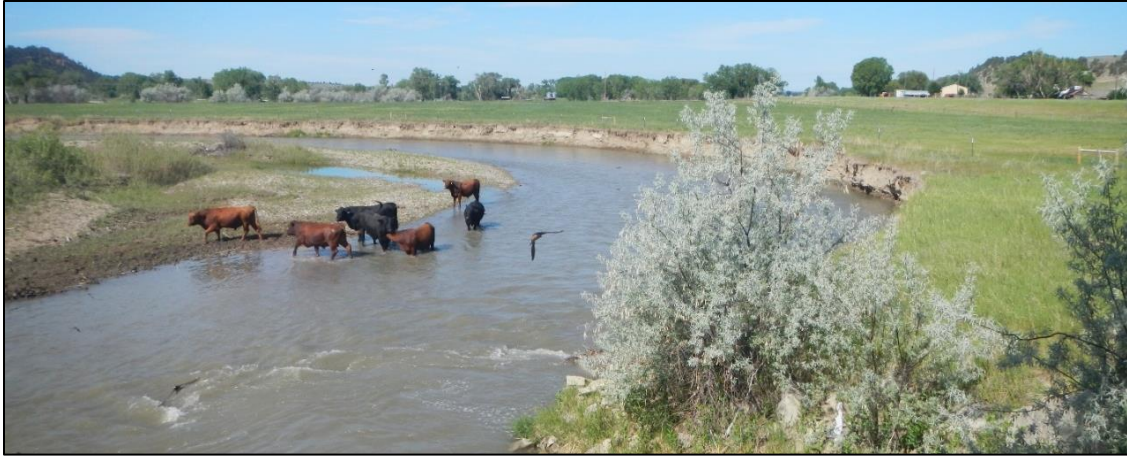
**Figure 52. View upstream from Buffalo Trail Bridge showing channel migrating to right (northward), flanking rock riprap that currently extends up to Russian olive. The mid-channel turbulence is caused by flanked armor that is now in the channel.**

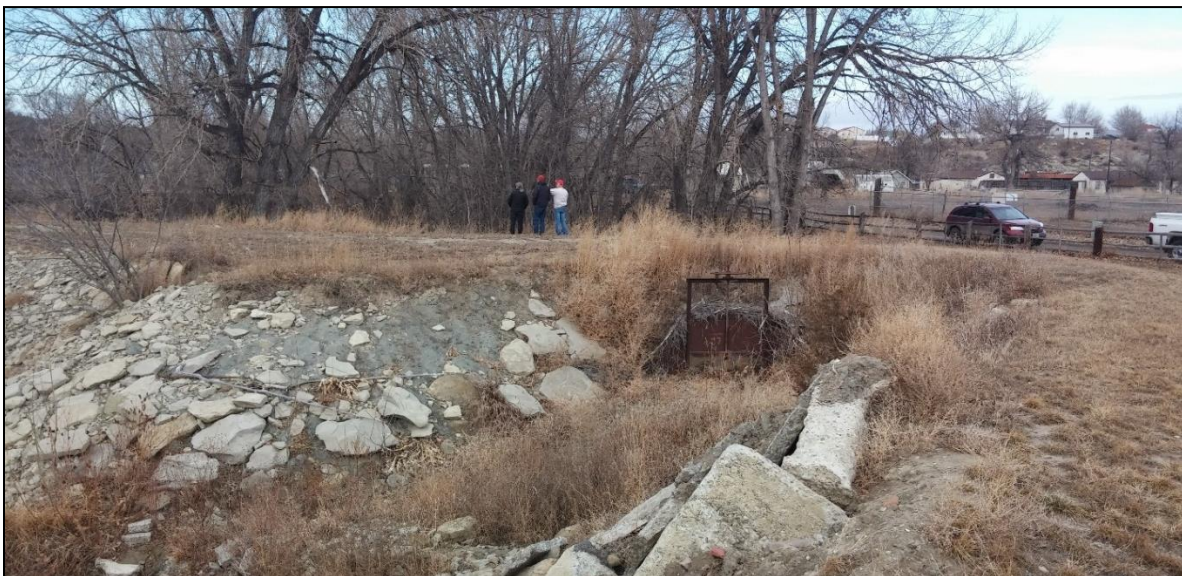
**Figure 56. View north from bank of Musselshell River to floodwater return flow culvert pipe at Meathouse Road in Roundup, February 10, 2015.**

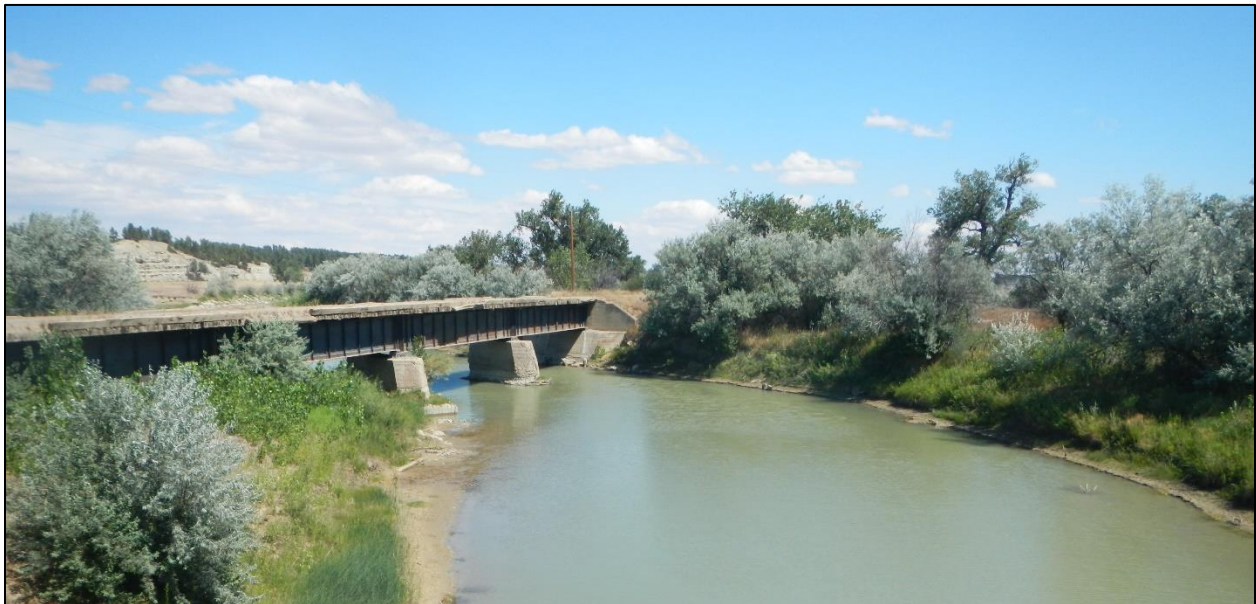
**Figure 59. View downstream from Goffena Bridge showing poorly aligned historic Milwaukee Road bridge about 250 feet downstream.**

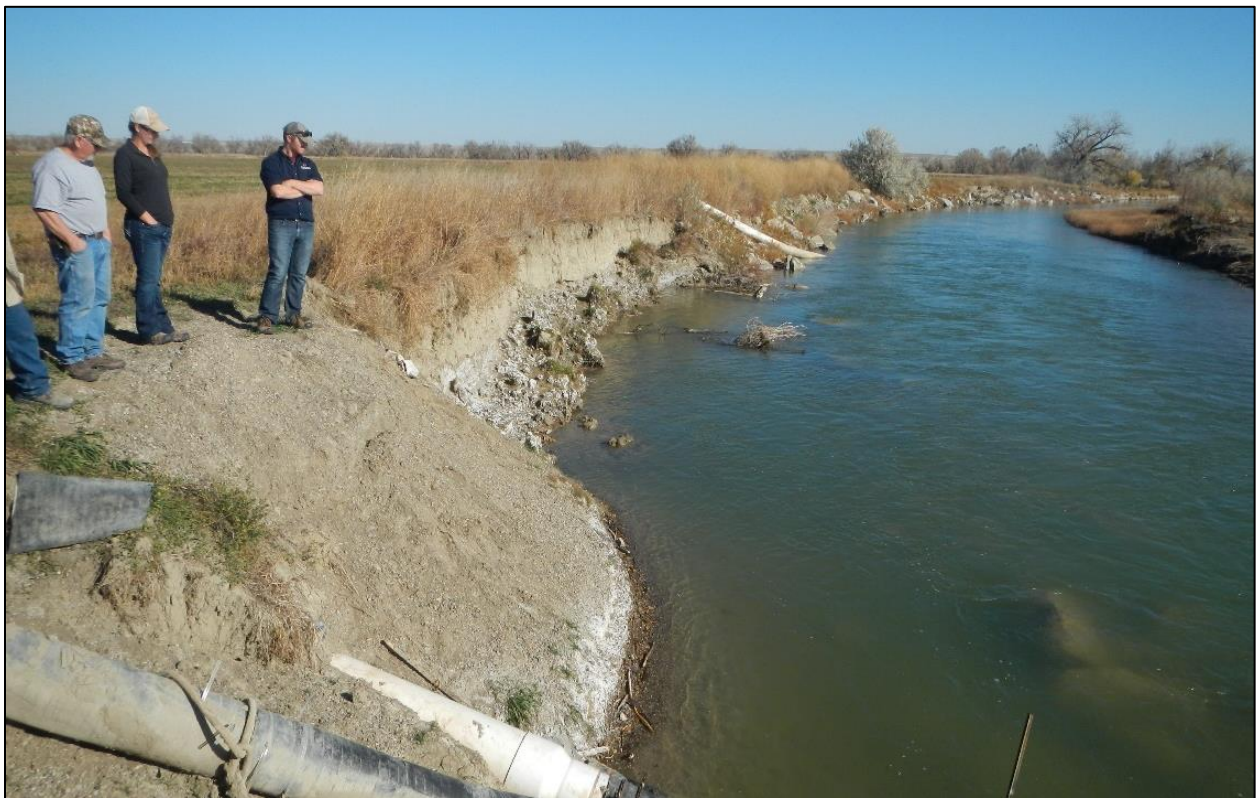
**Figure 62. View downstream of damaged pump site; note flanked riprap in channel.**
